**LAVORI DI MANUTENZIONE  
STRAORDINARIA VIABILITA' E  
INFRASTRUTTURE CONNESSE (MESSE IN  
SICUREZZA VARI TRATTI DI STRADE  
COMUNALI)**

**PROGETTO ESECUTIVO**

**ELABORATI GRAFICI: PLANIMETRIE E DOCUMENTAZIONE FOTOGRAFICA DEI  
SINGOLI INTERVENTI, PARTICOLARI COSTRUTTIVI**

**D1**

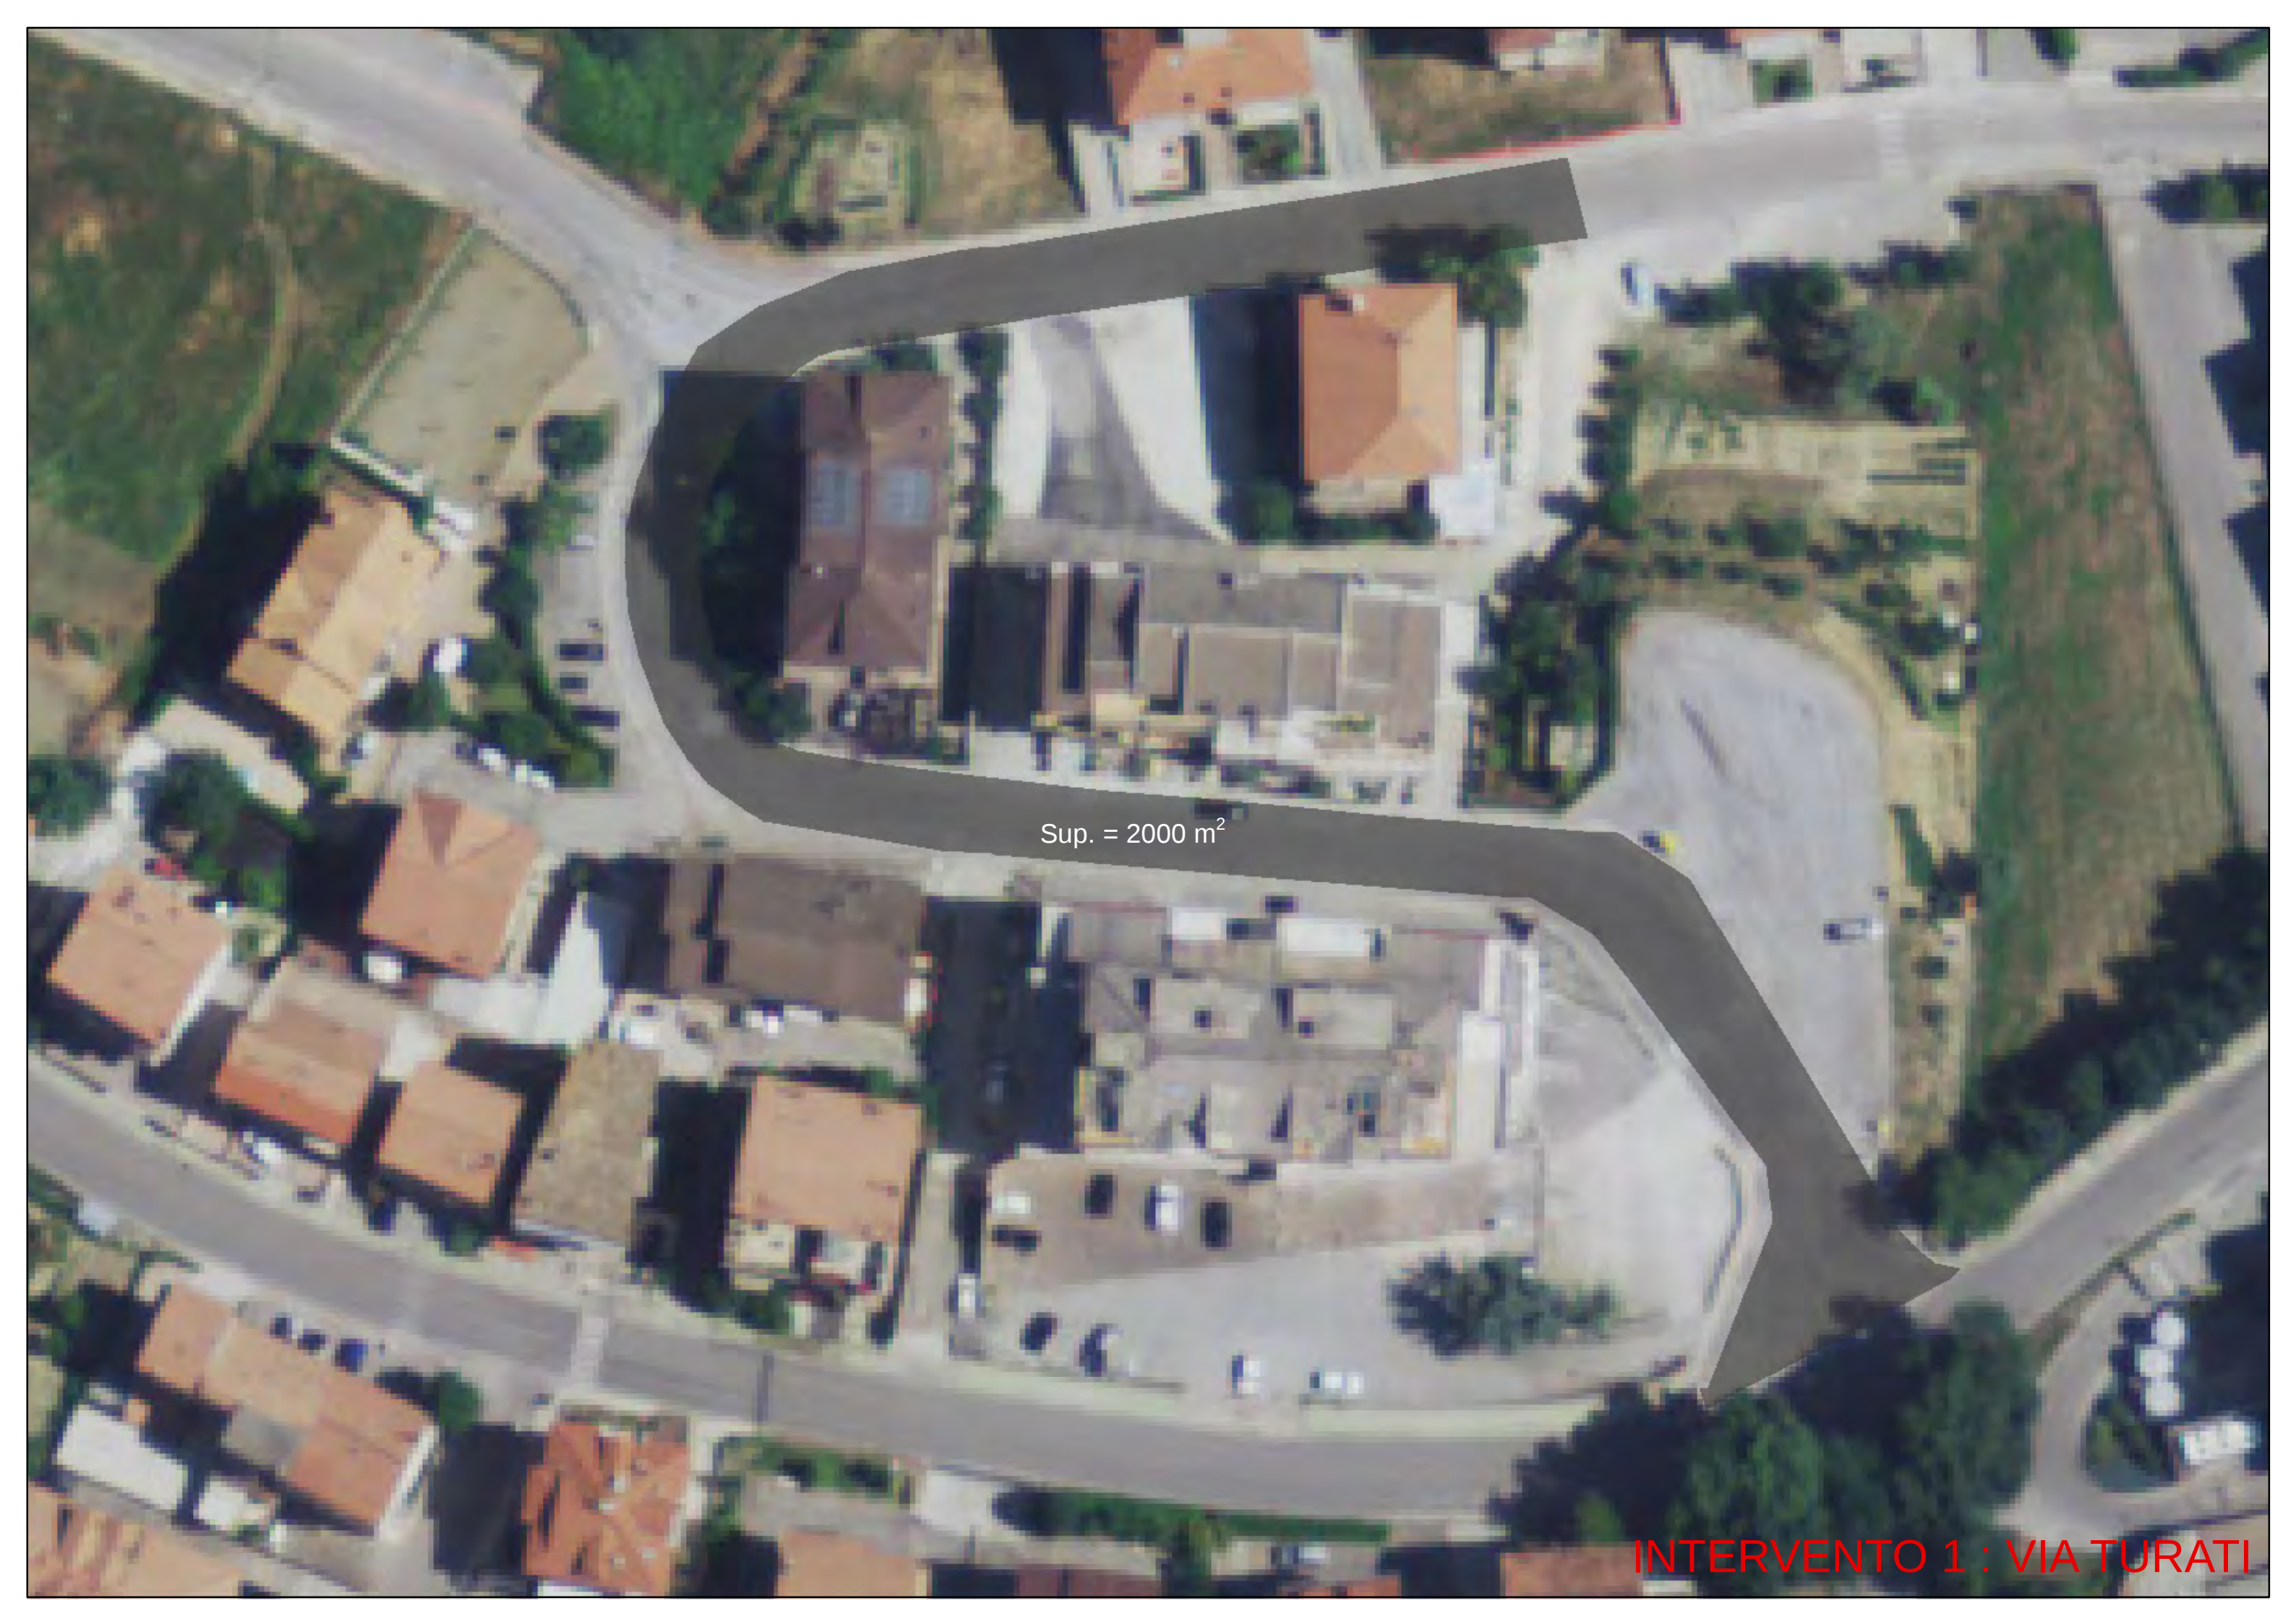
INTERVENTO 1 : VIA TURATI

Sup. = 2000 m<sup>2</sup>

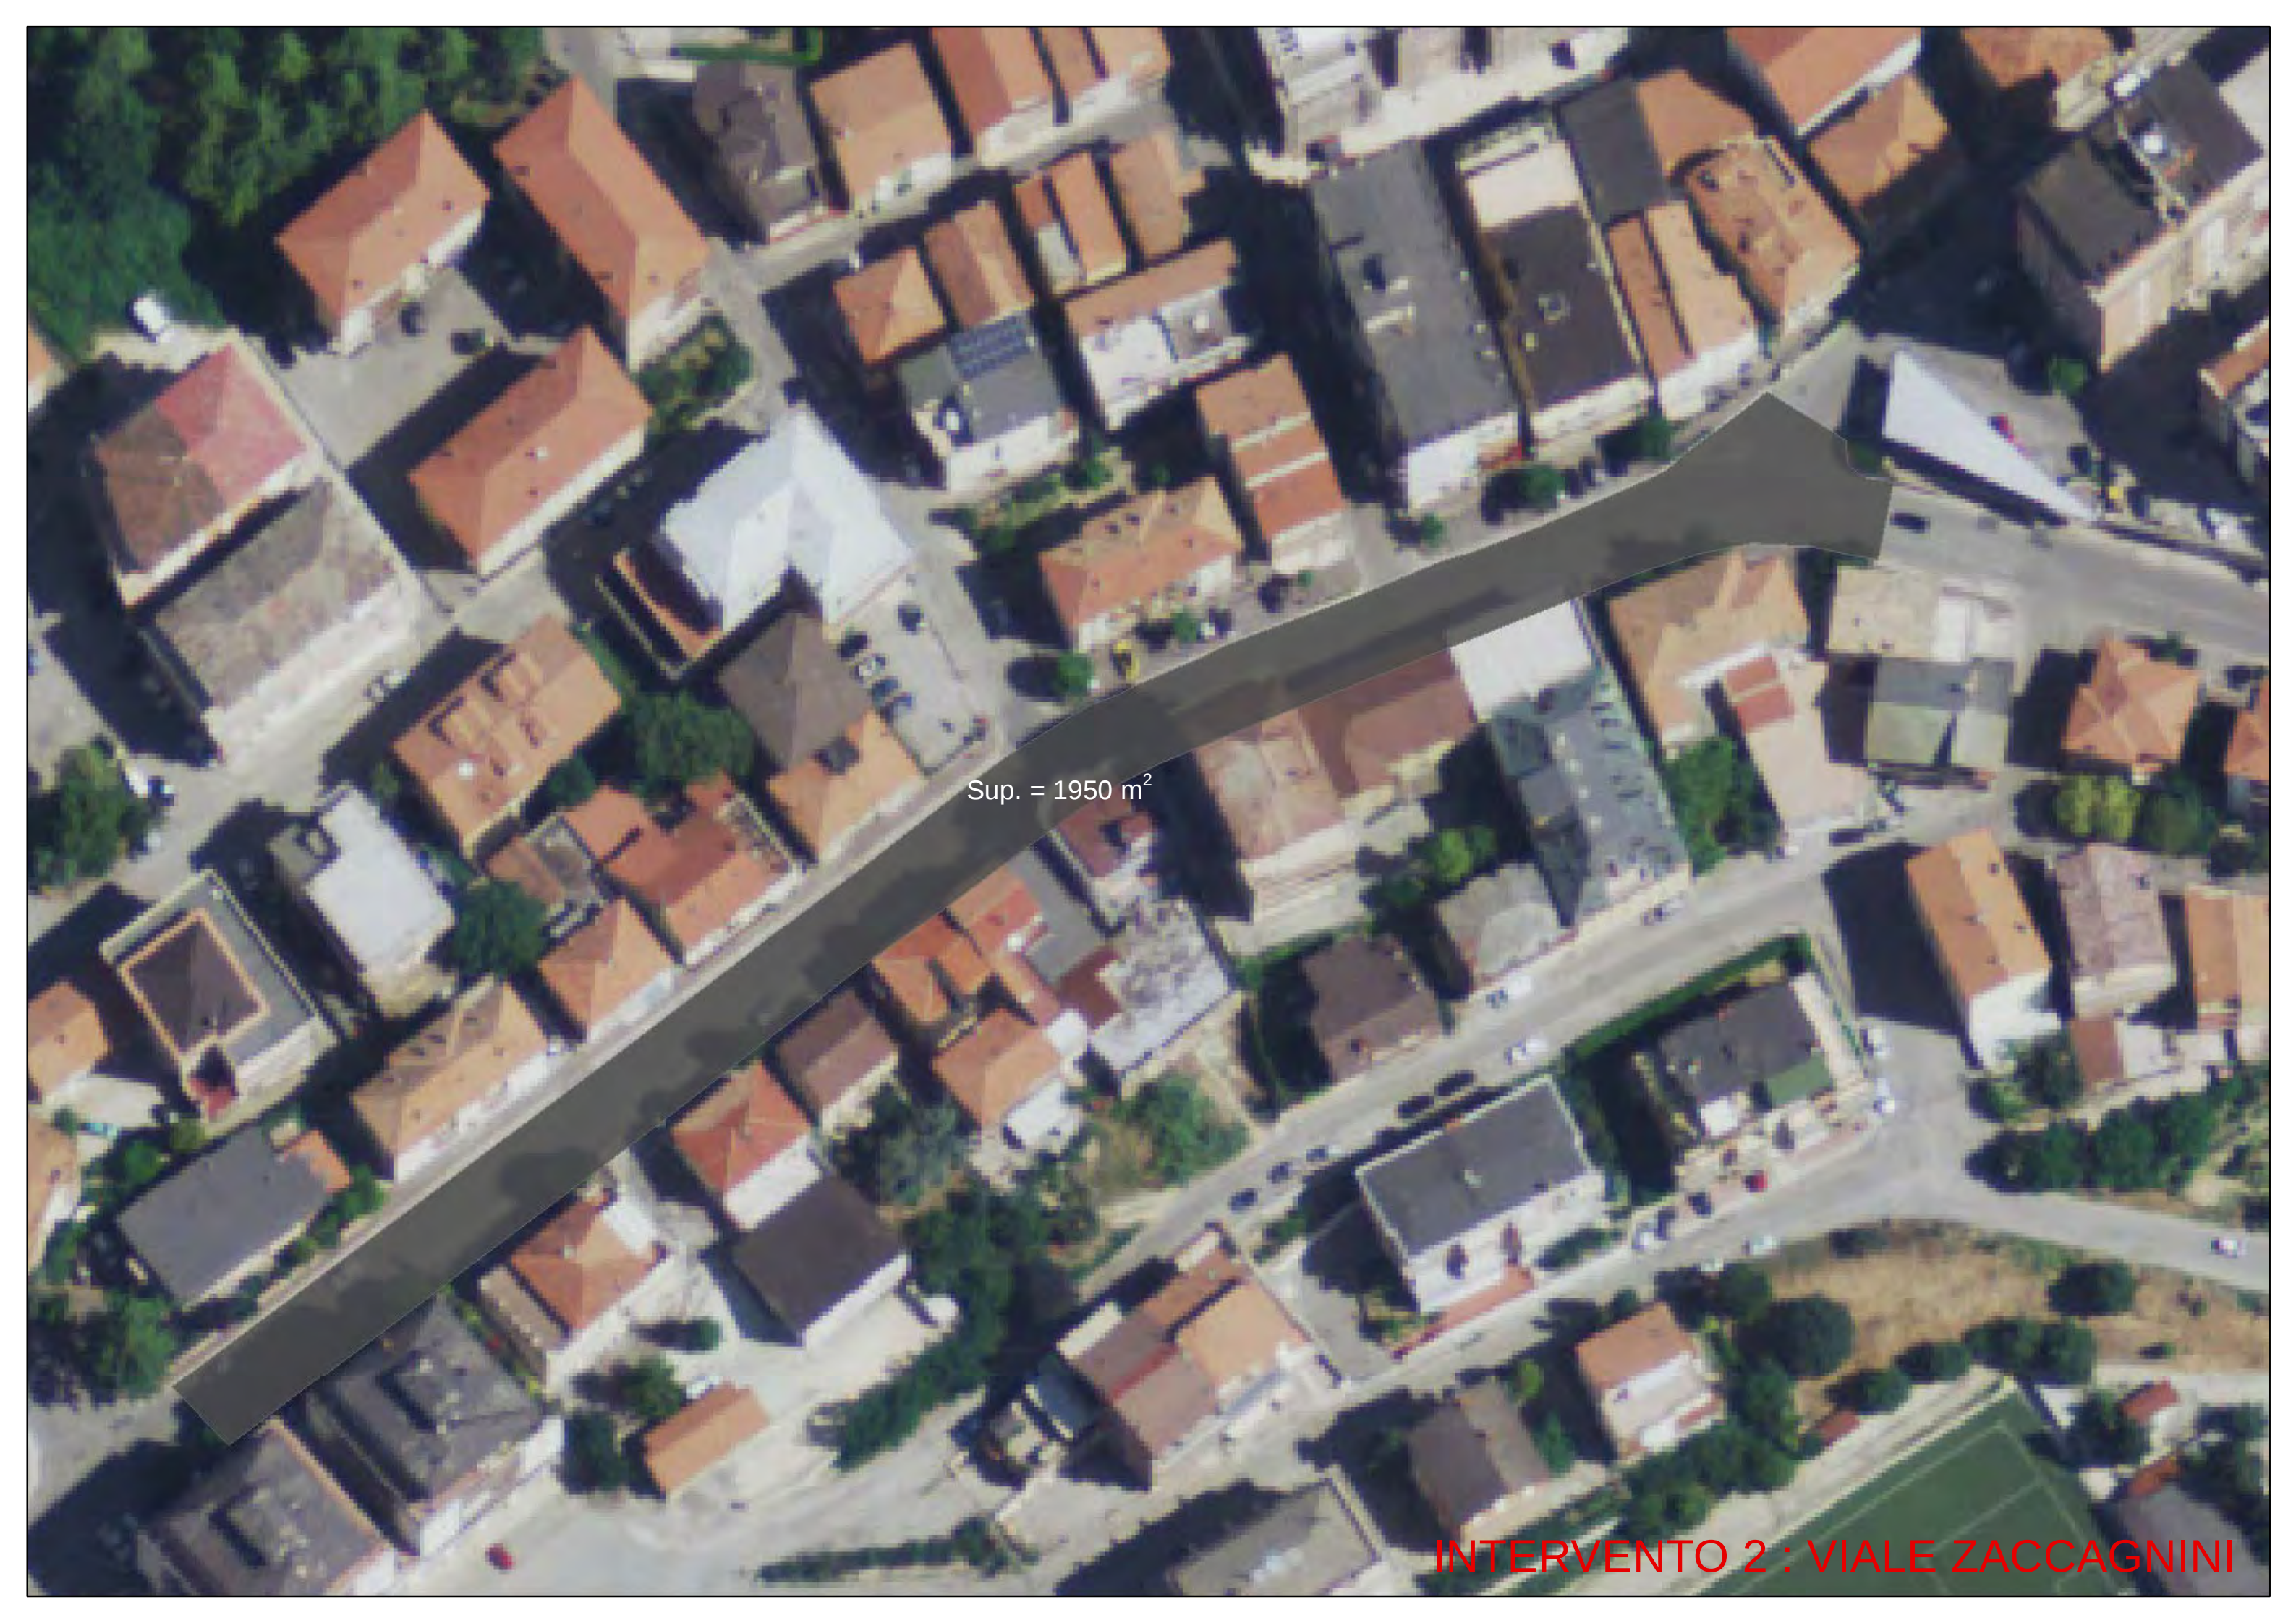
INTERVENTO 2 : VIALE ZACCAGNINI

Sup. = 1950 m<sup>2</sup>

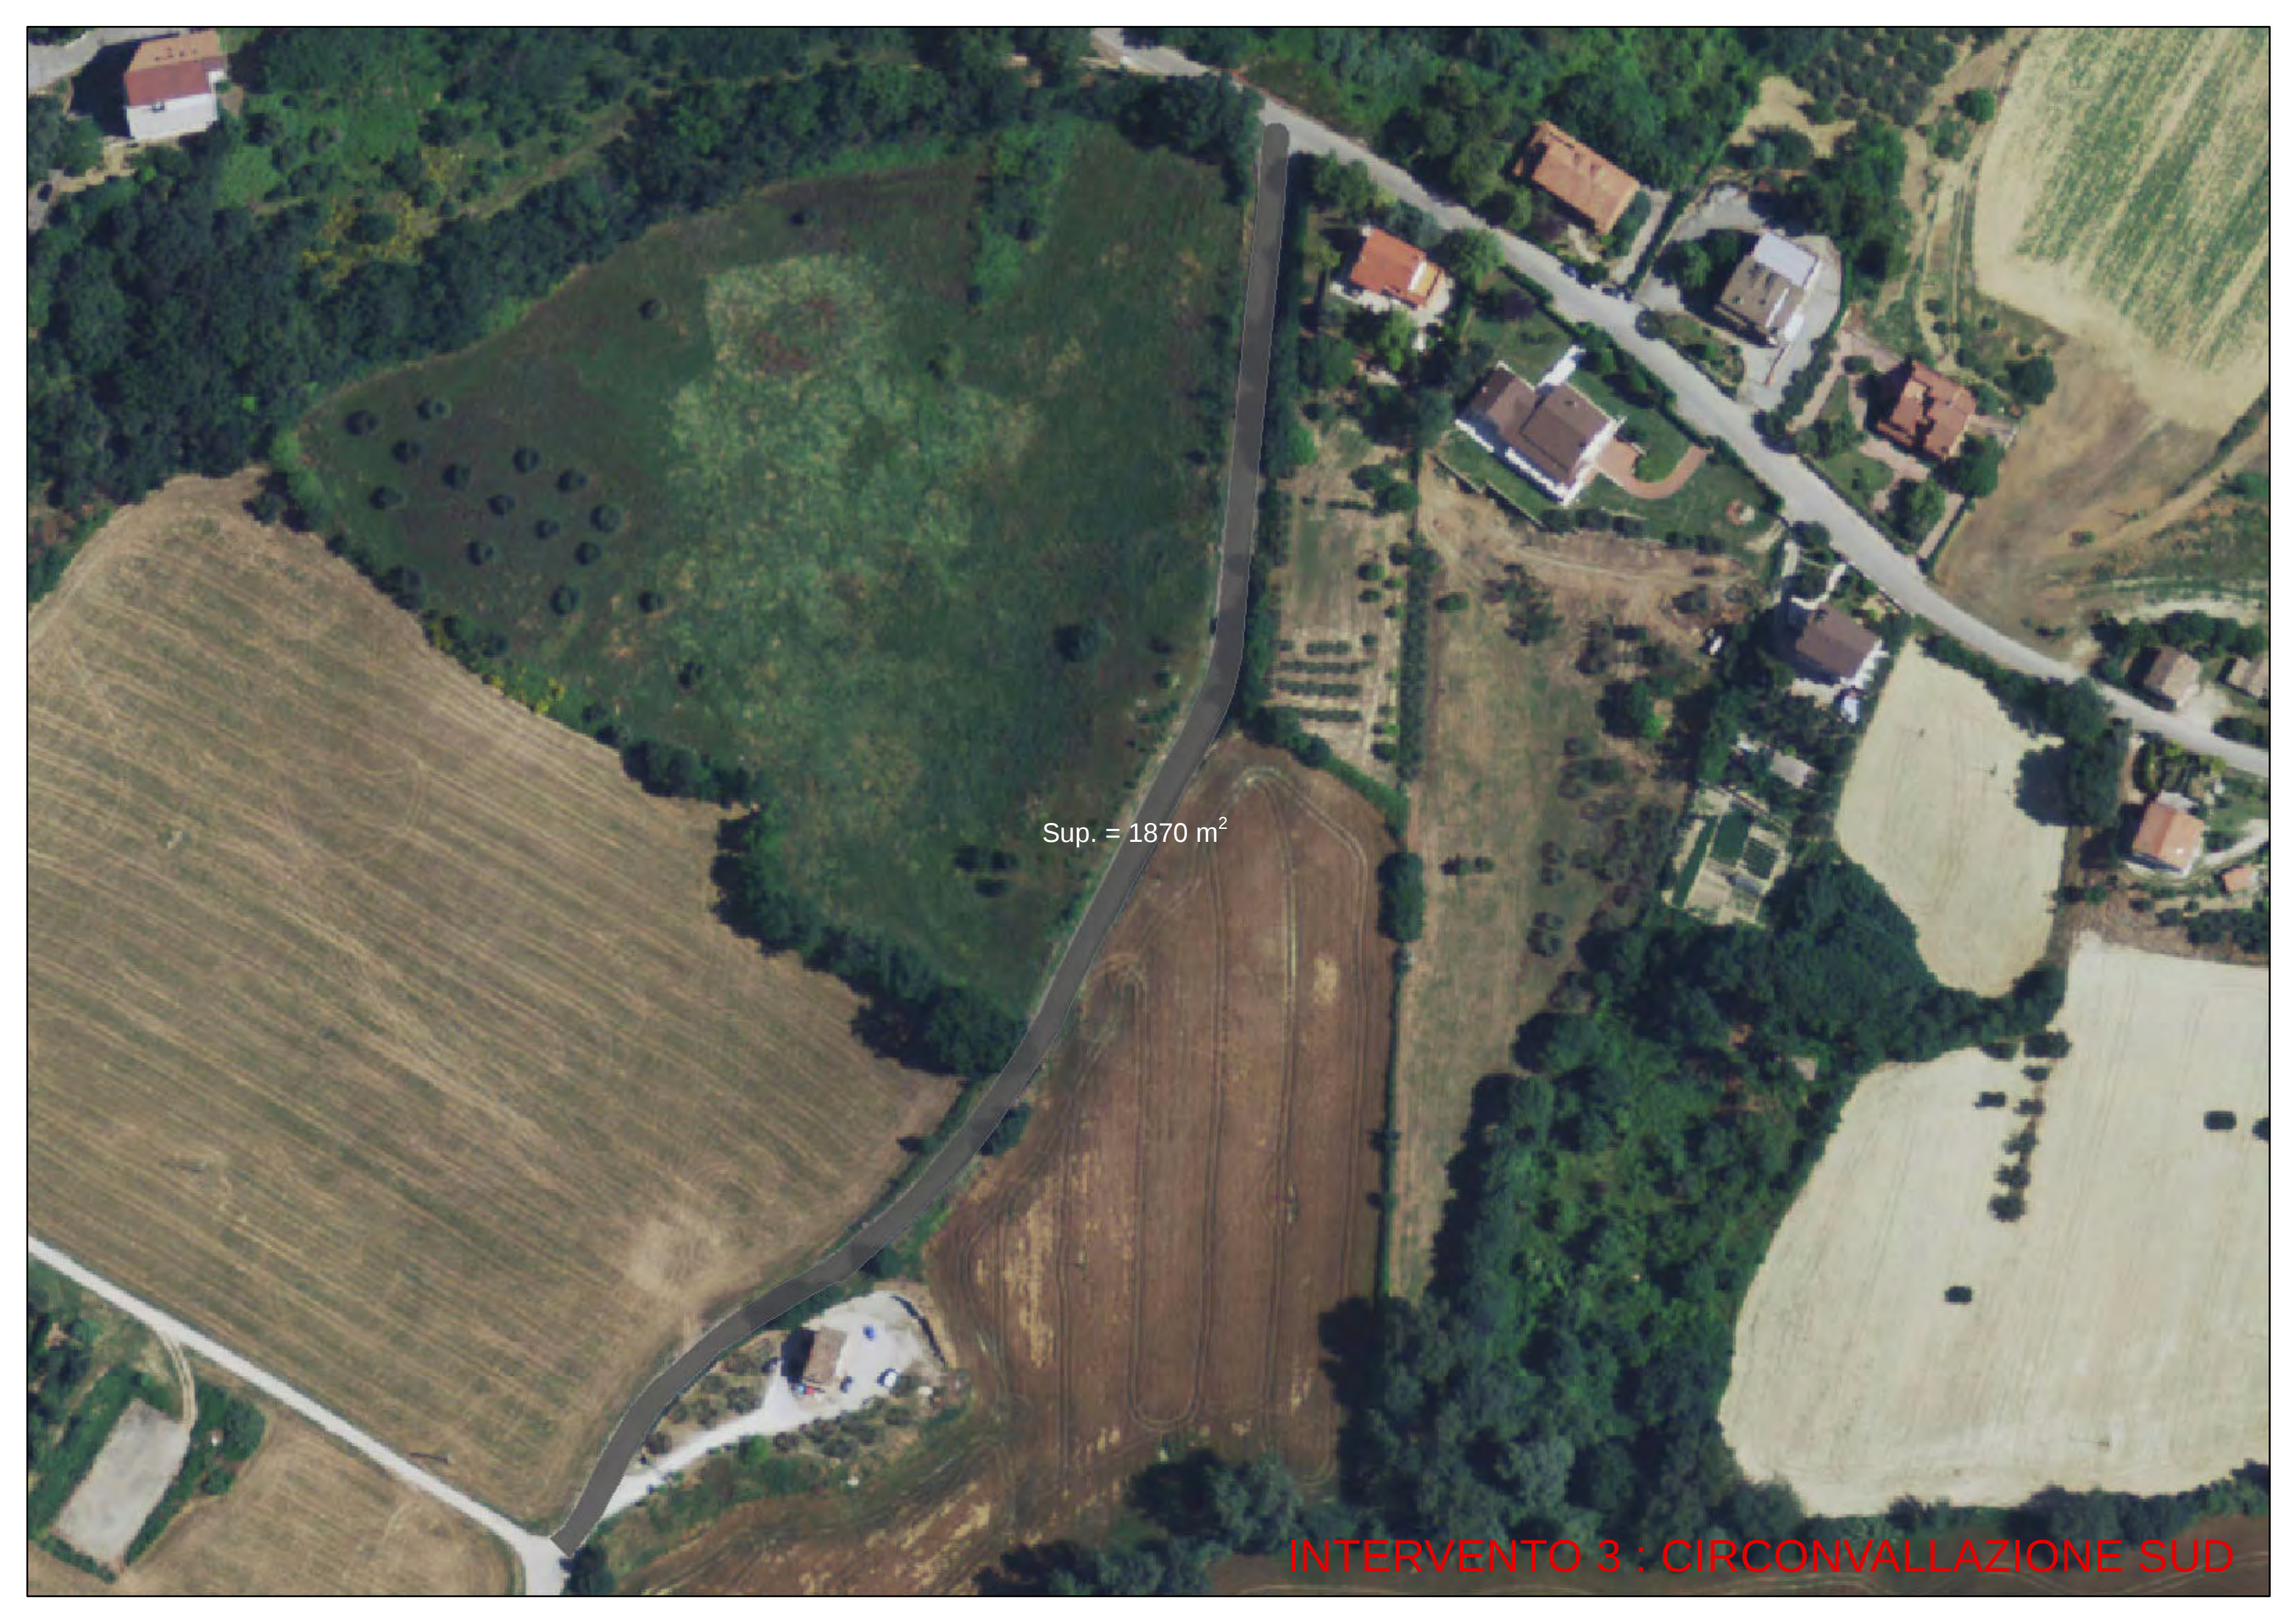
INTERVENTO 3 : CIRCONVALLAZIONE SUD

Sup. = 1870 m<sup>2</sup>

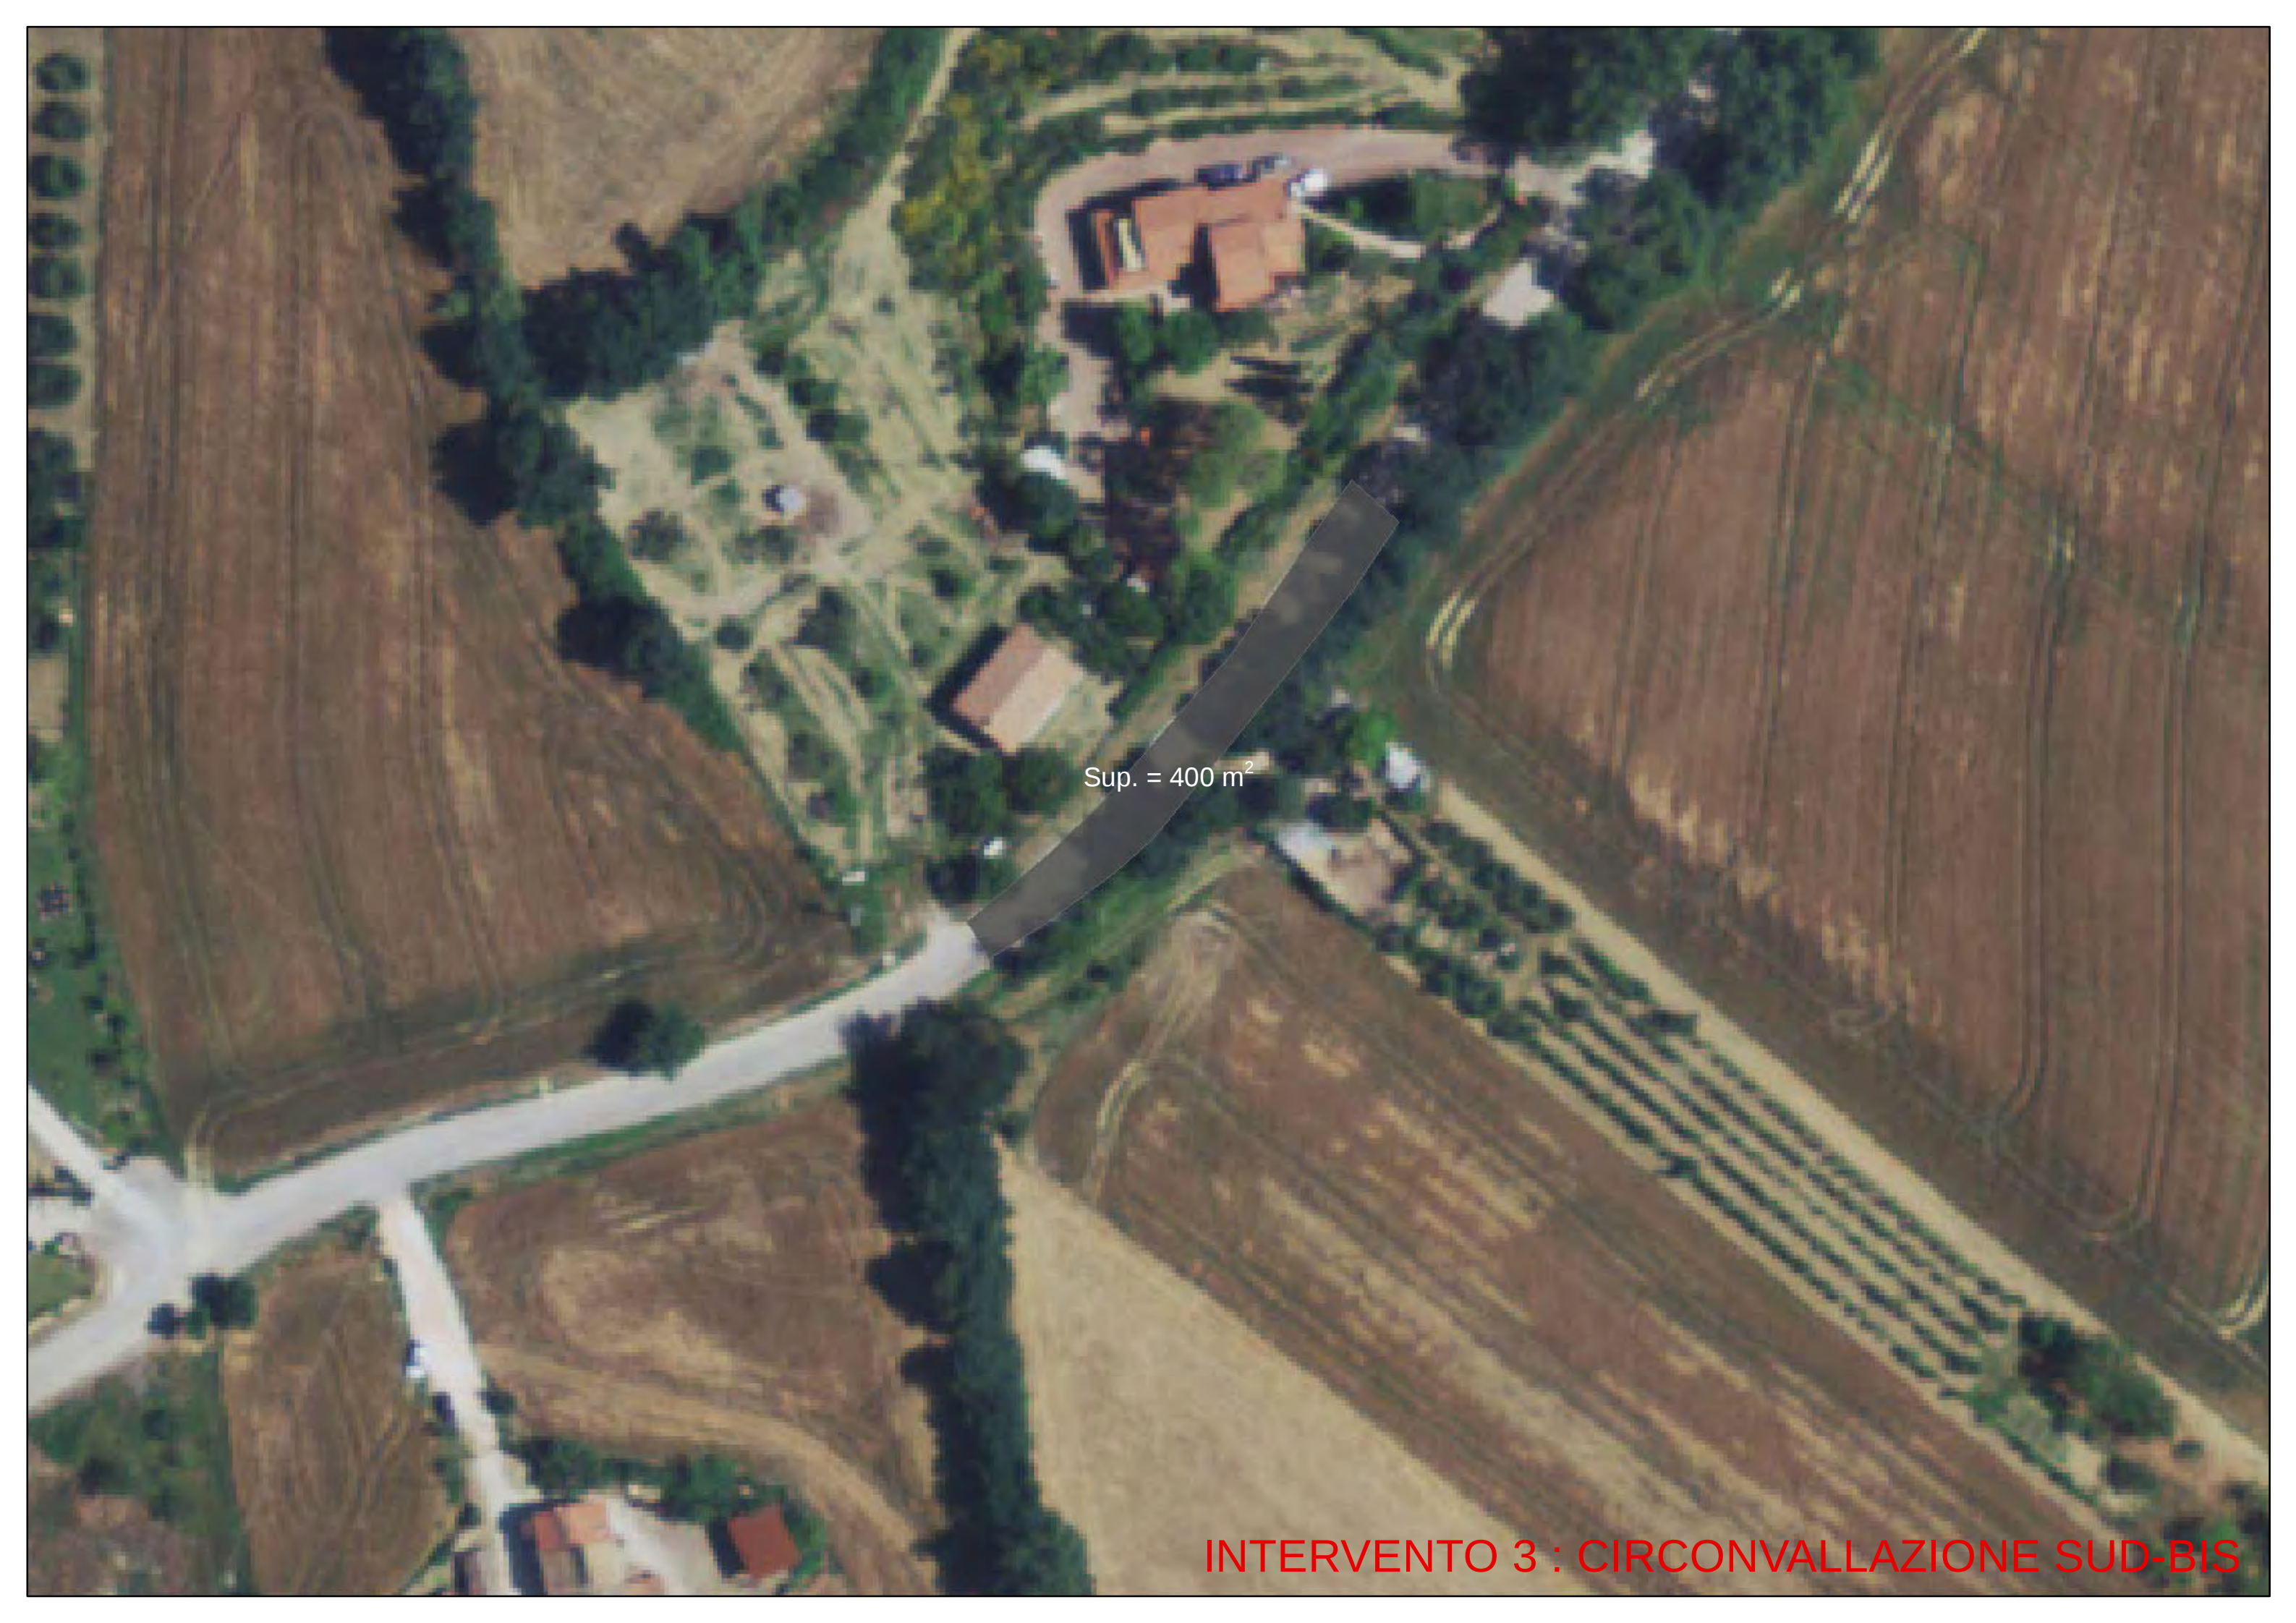
INTERVENTO 3 : CIRCONVALLAZIONE SUD-BIS

Sup. = 400 m<sup>2</sup>

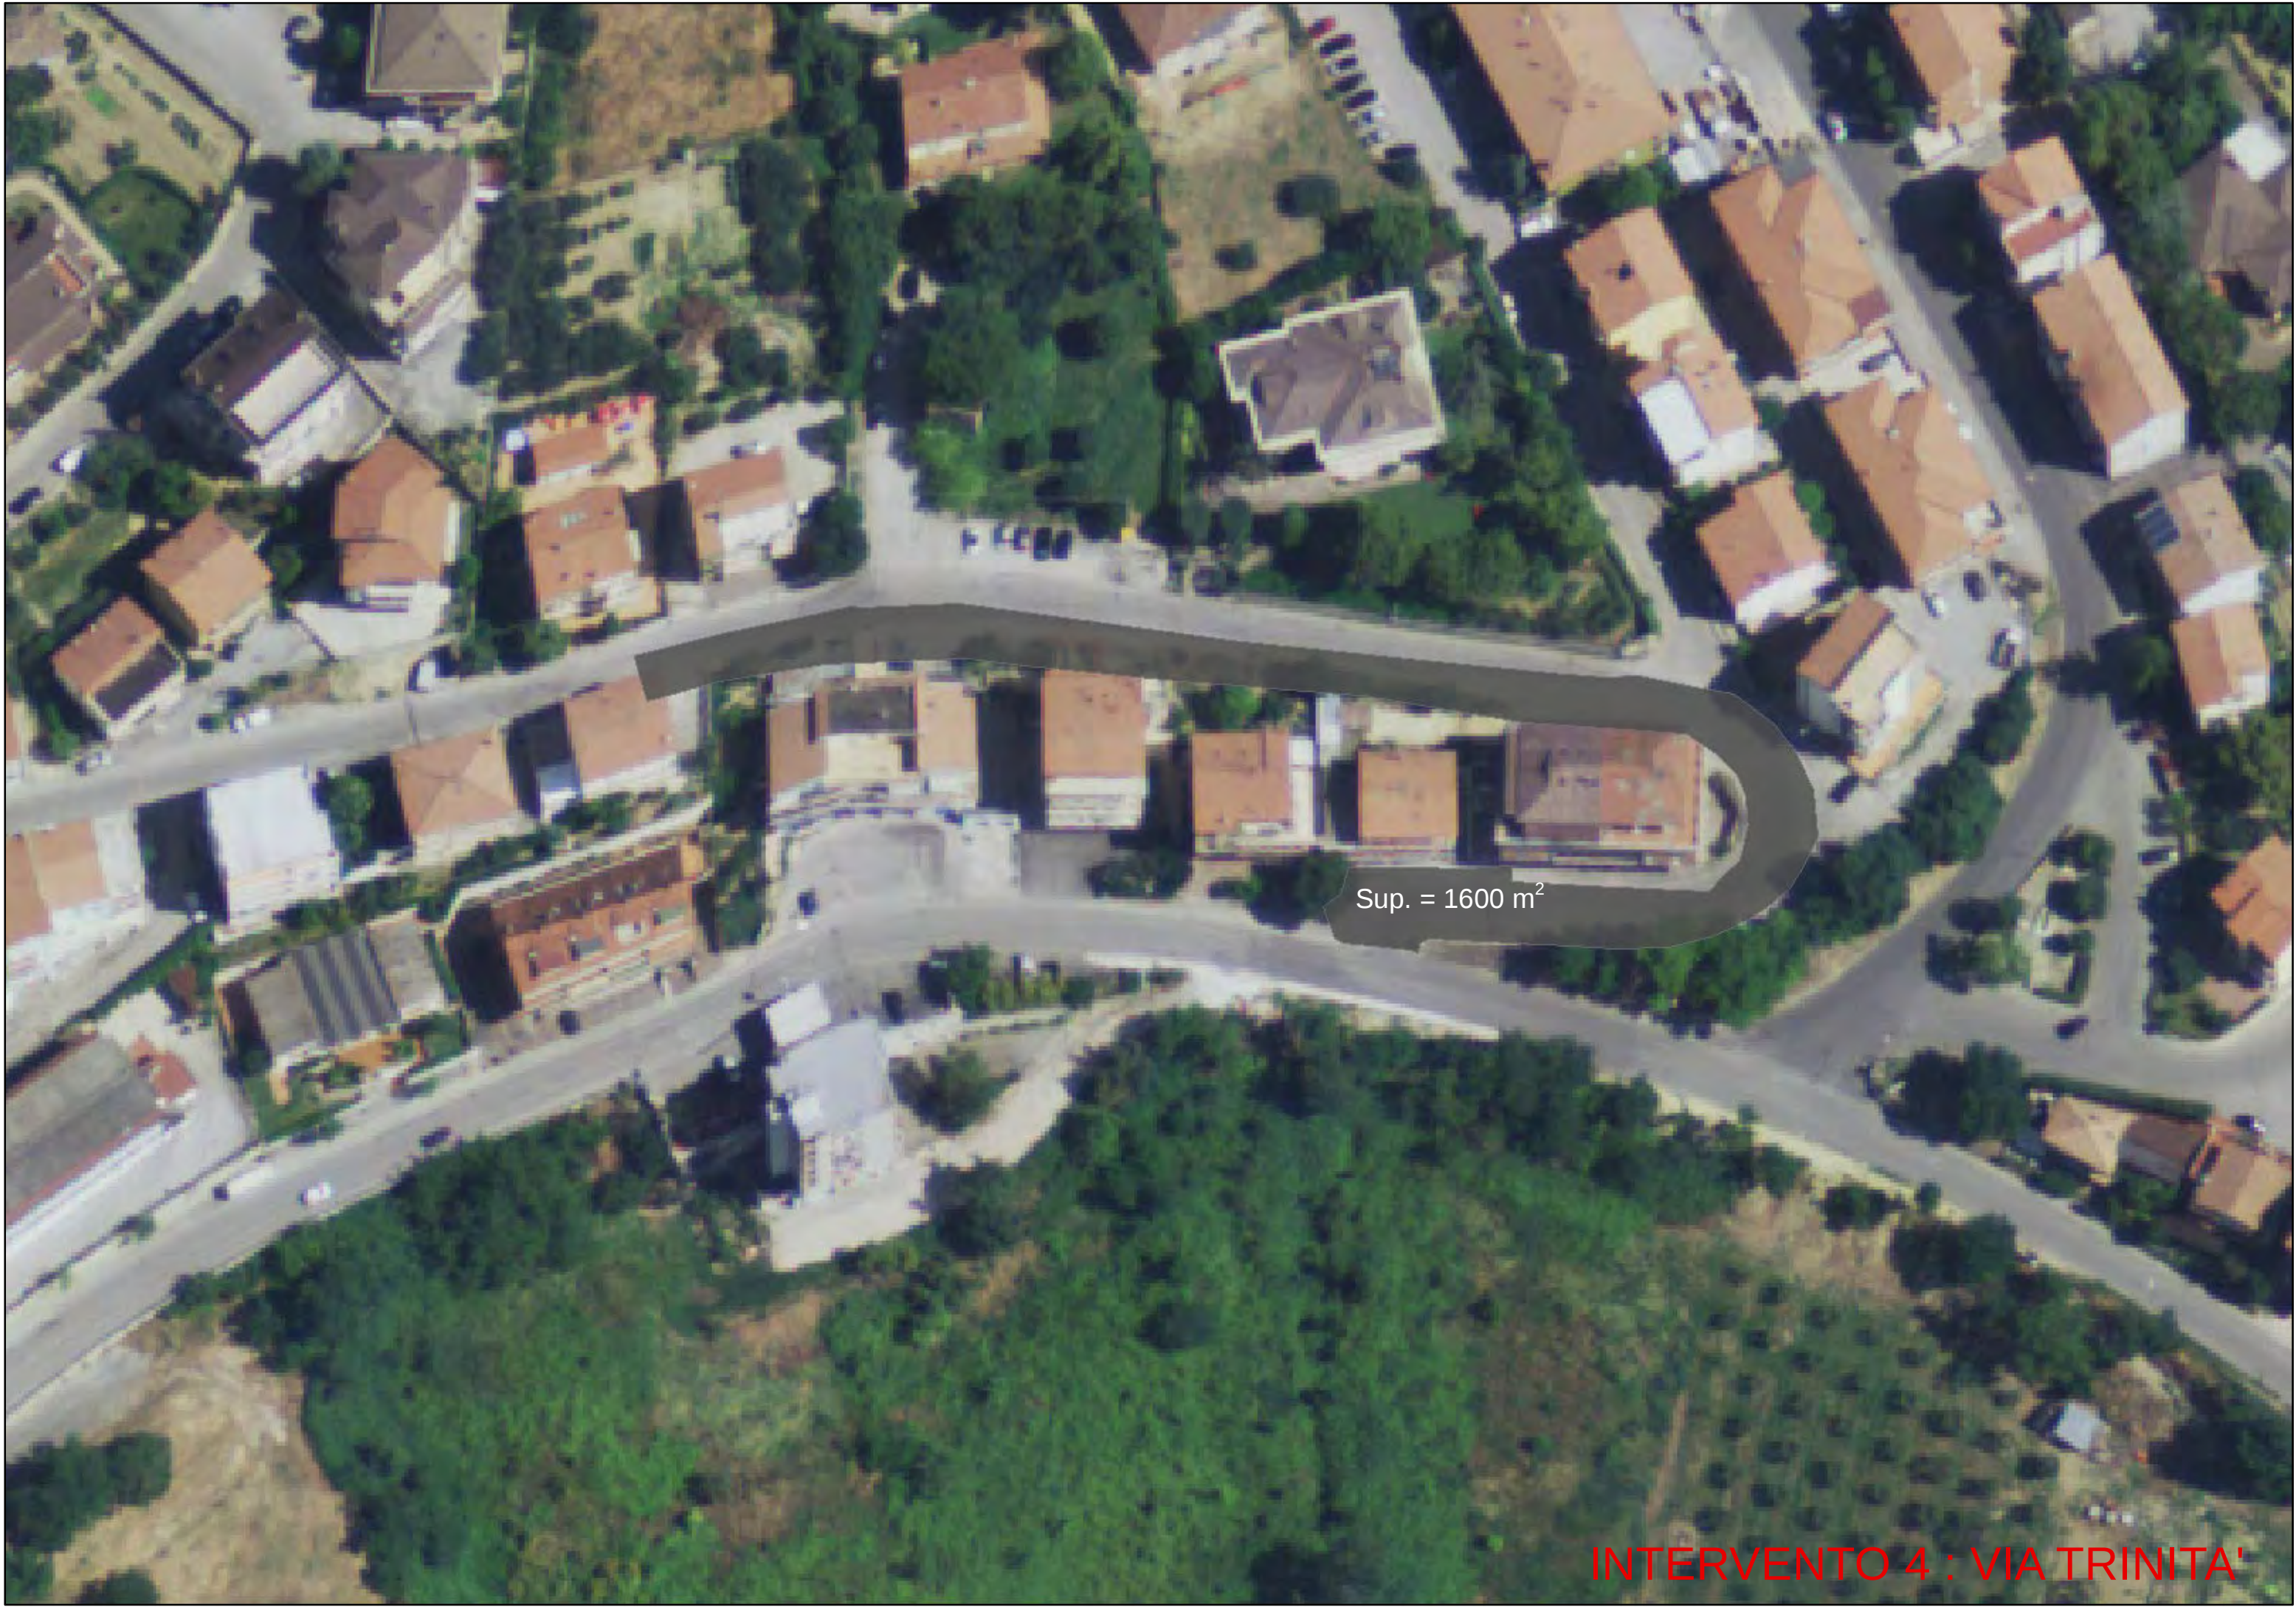
INTERVENTO 4 : VIA TRINITA'

Sup. = 1600 m<sup>2</sup>

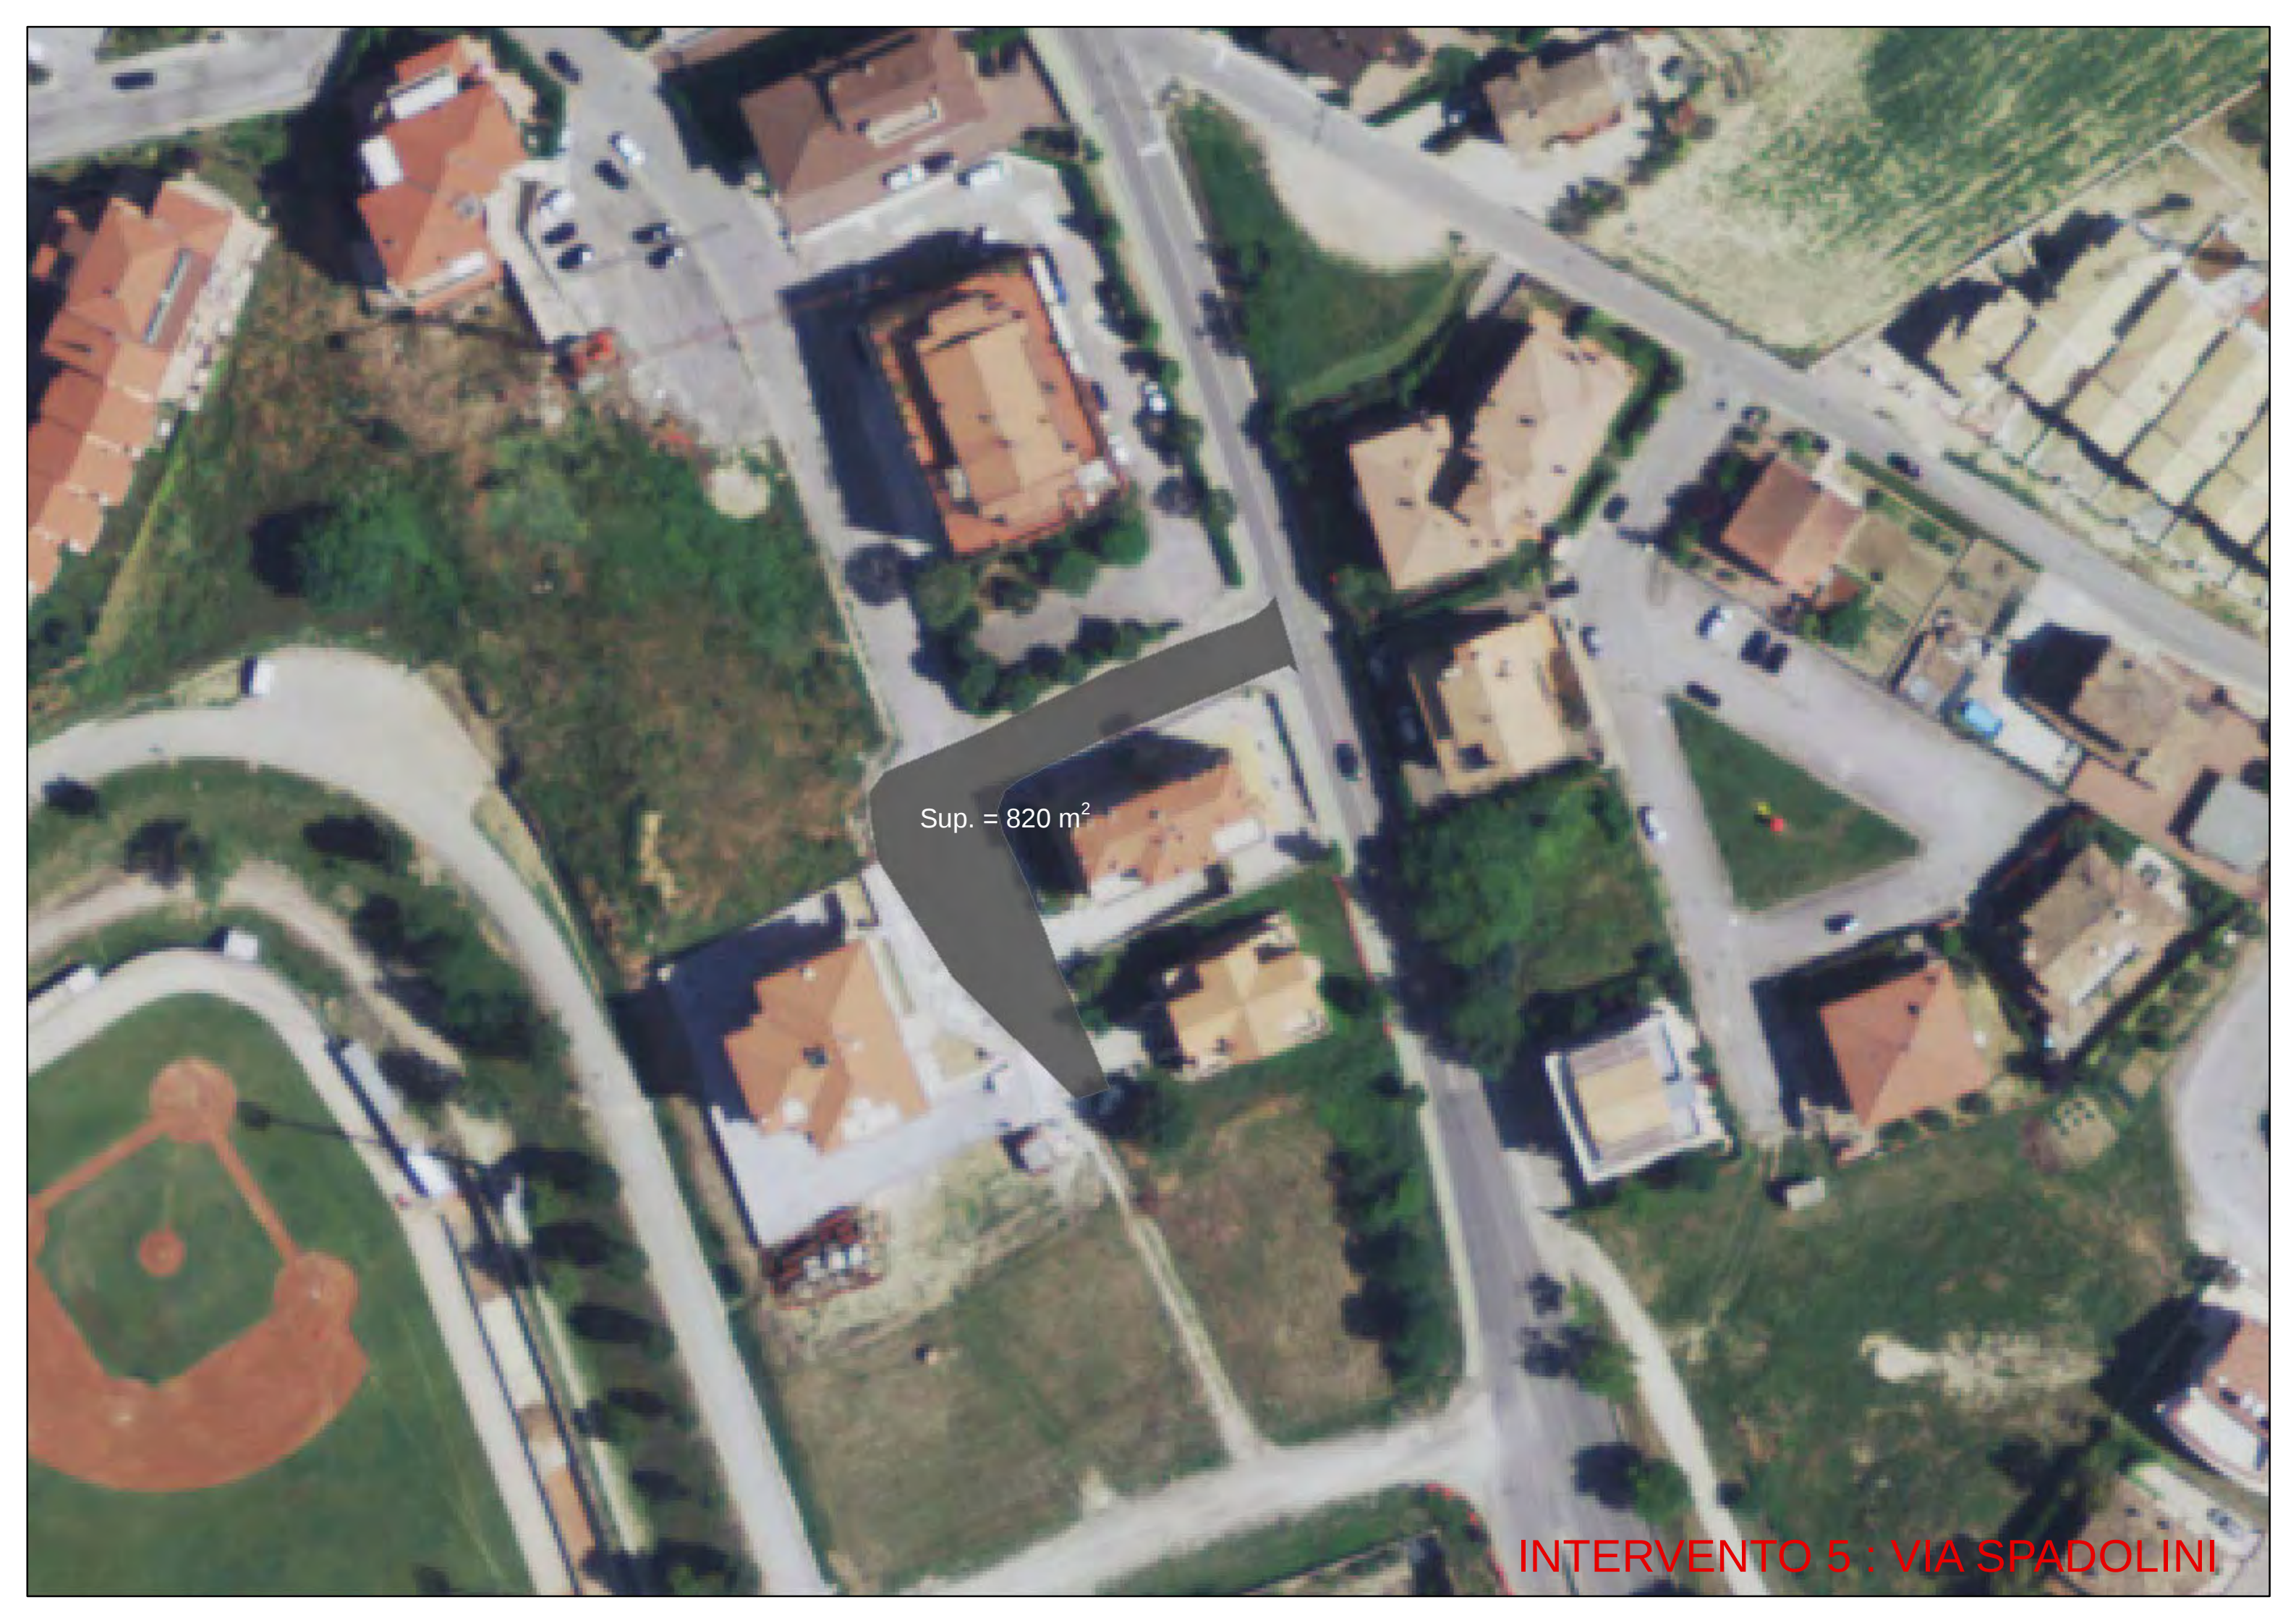
INTERVENTO 5 : VIA SPADOLINI

Sup. = 820 m<sup>2</sup>
