**LAVORI DI MANUTENZIONE  
STRAORDINARIA VIABILITA' E  
INFRASTRUTTURE CONNESSE (MESSE IN  
SICUREZZA VARI TRATTI DI STRADE  
COMUNALI)**

**PROGETTO ESECUTIVO**

**ELABORATI GRAFICI: PLANIMETRIE E DOCUMENTAZIONE FOTOGRAFICA DEI  
SINGOLI INTERVENTI, PARTICOLARI COSTRUTTIVI**

**D1**

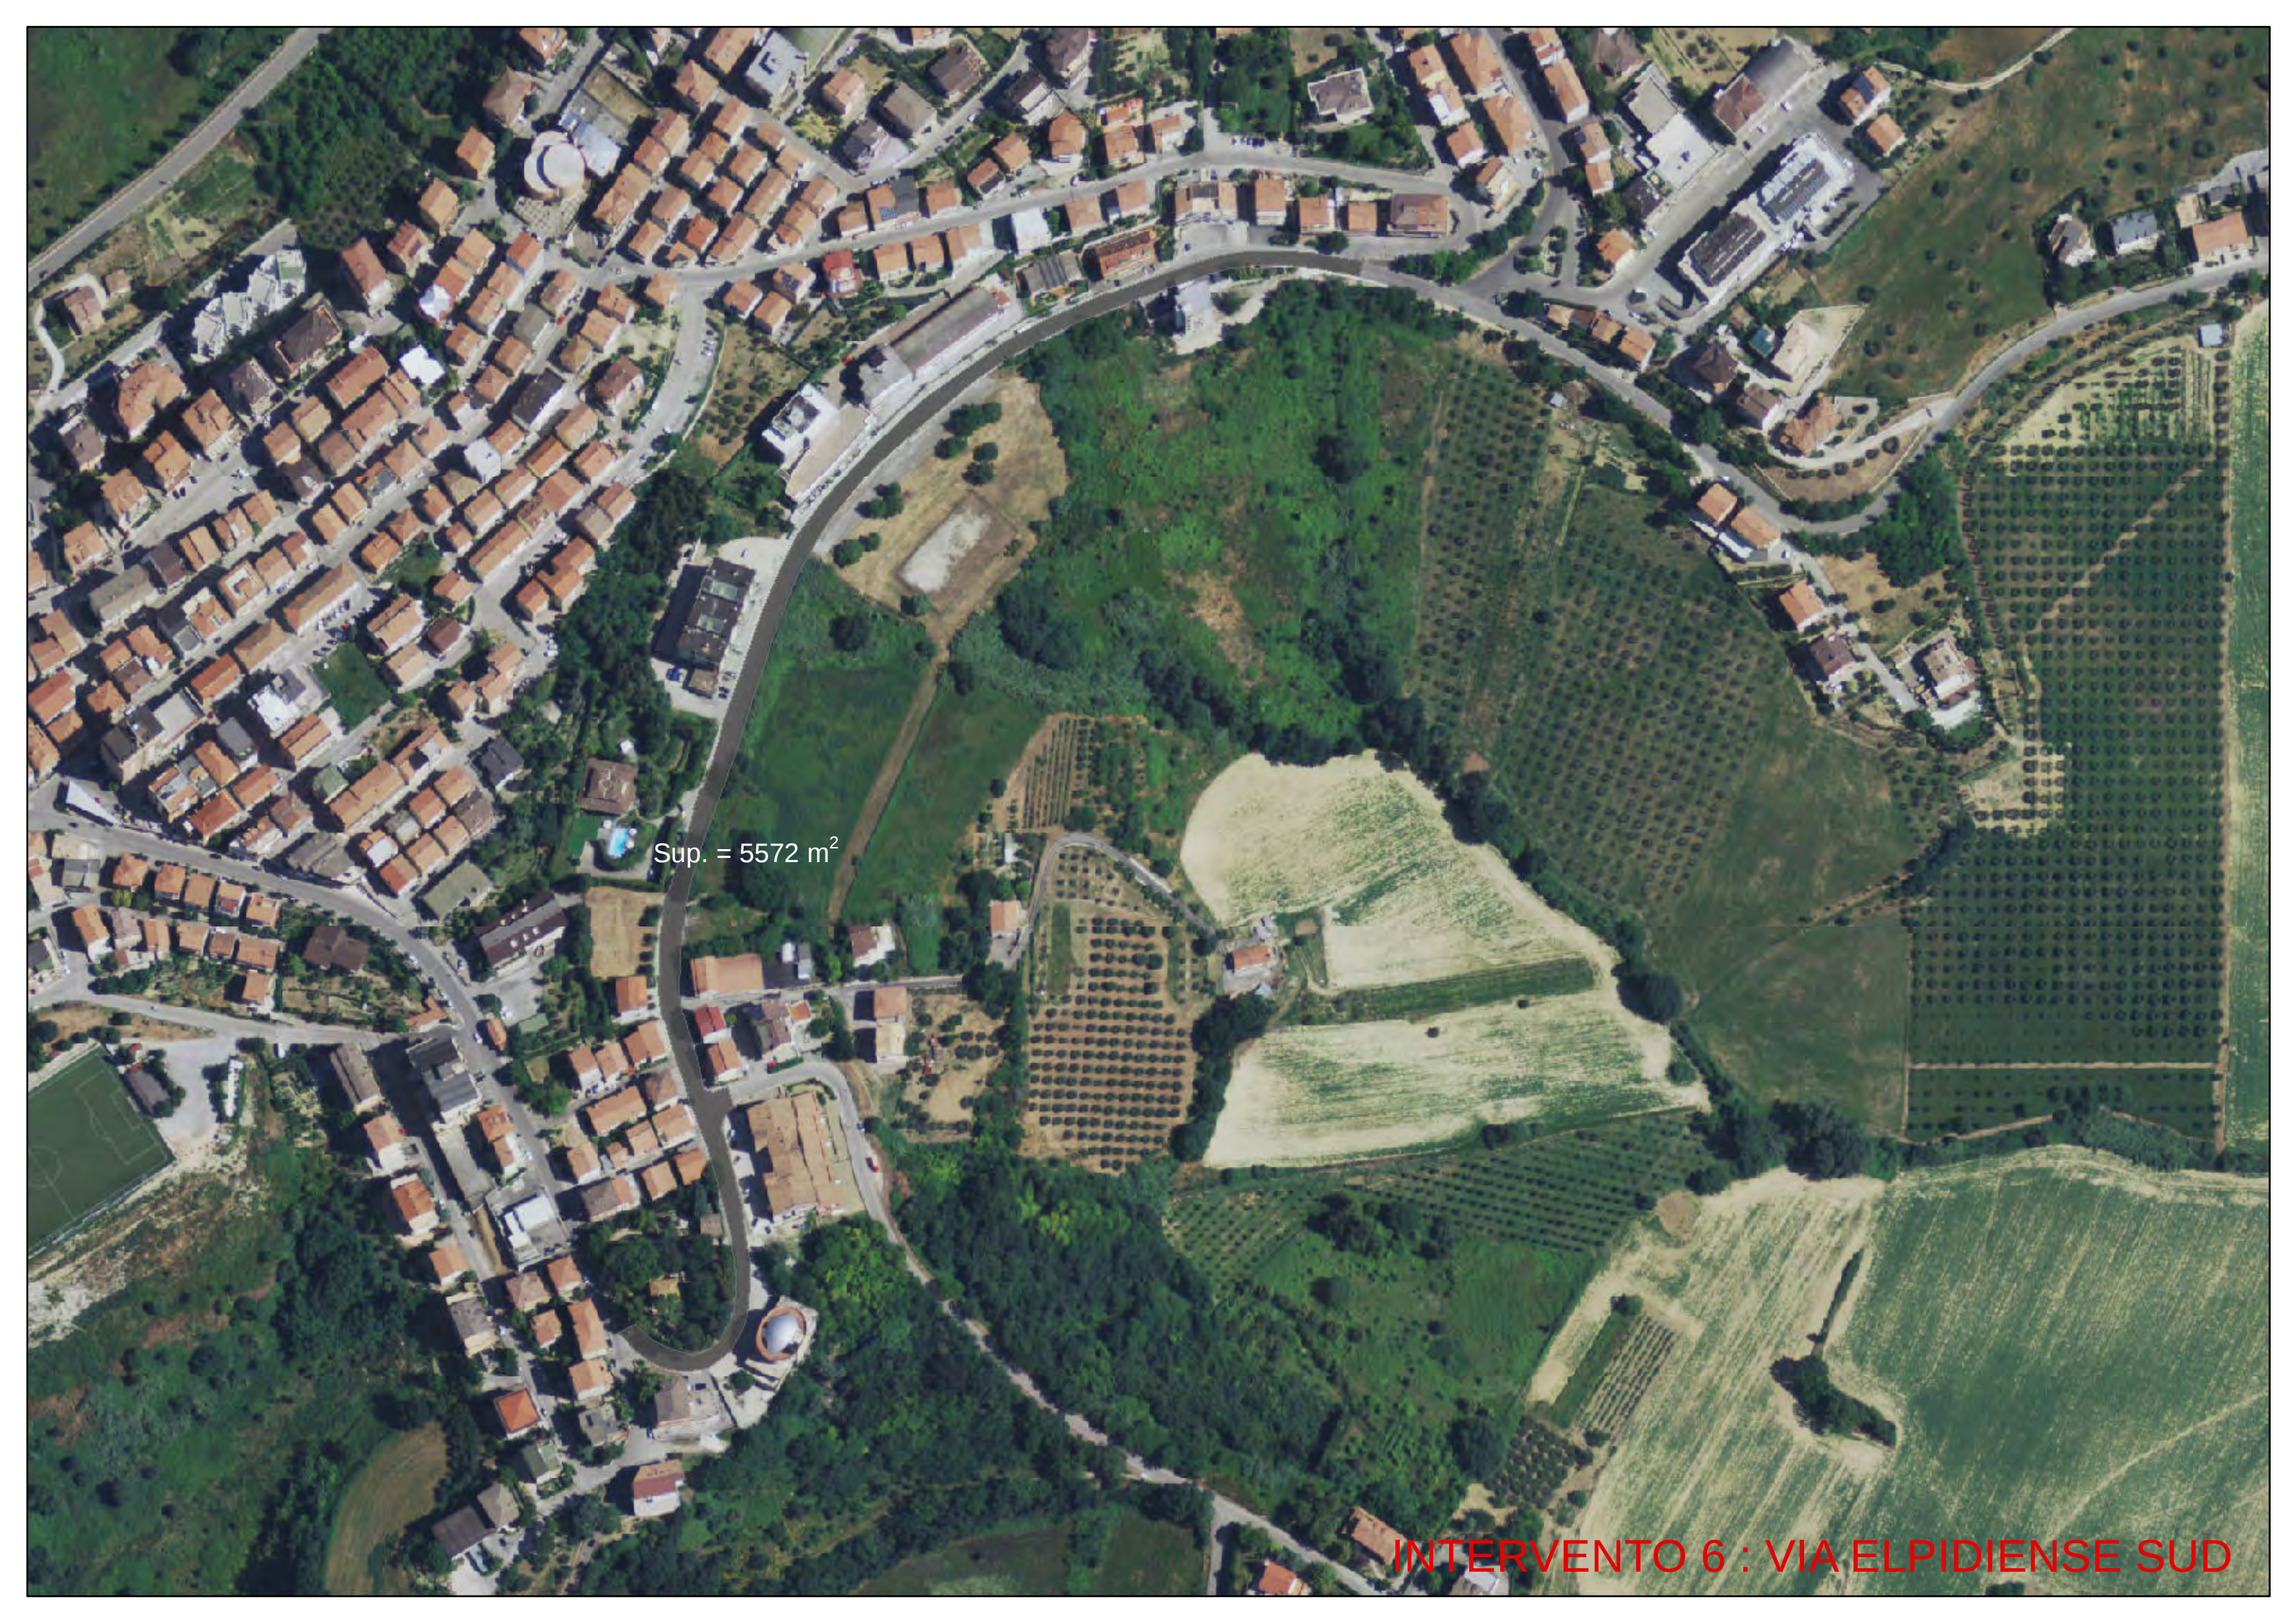
INTERVENTO 6 : VIA ELPIDIENSE SUD

Sup. = 5572 m<sup>2</sup>

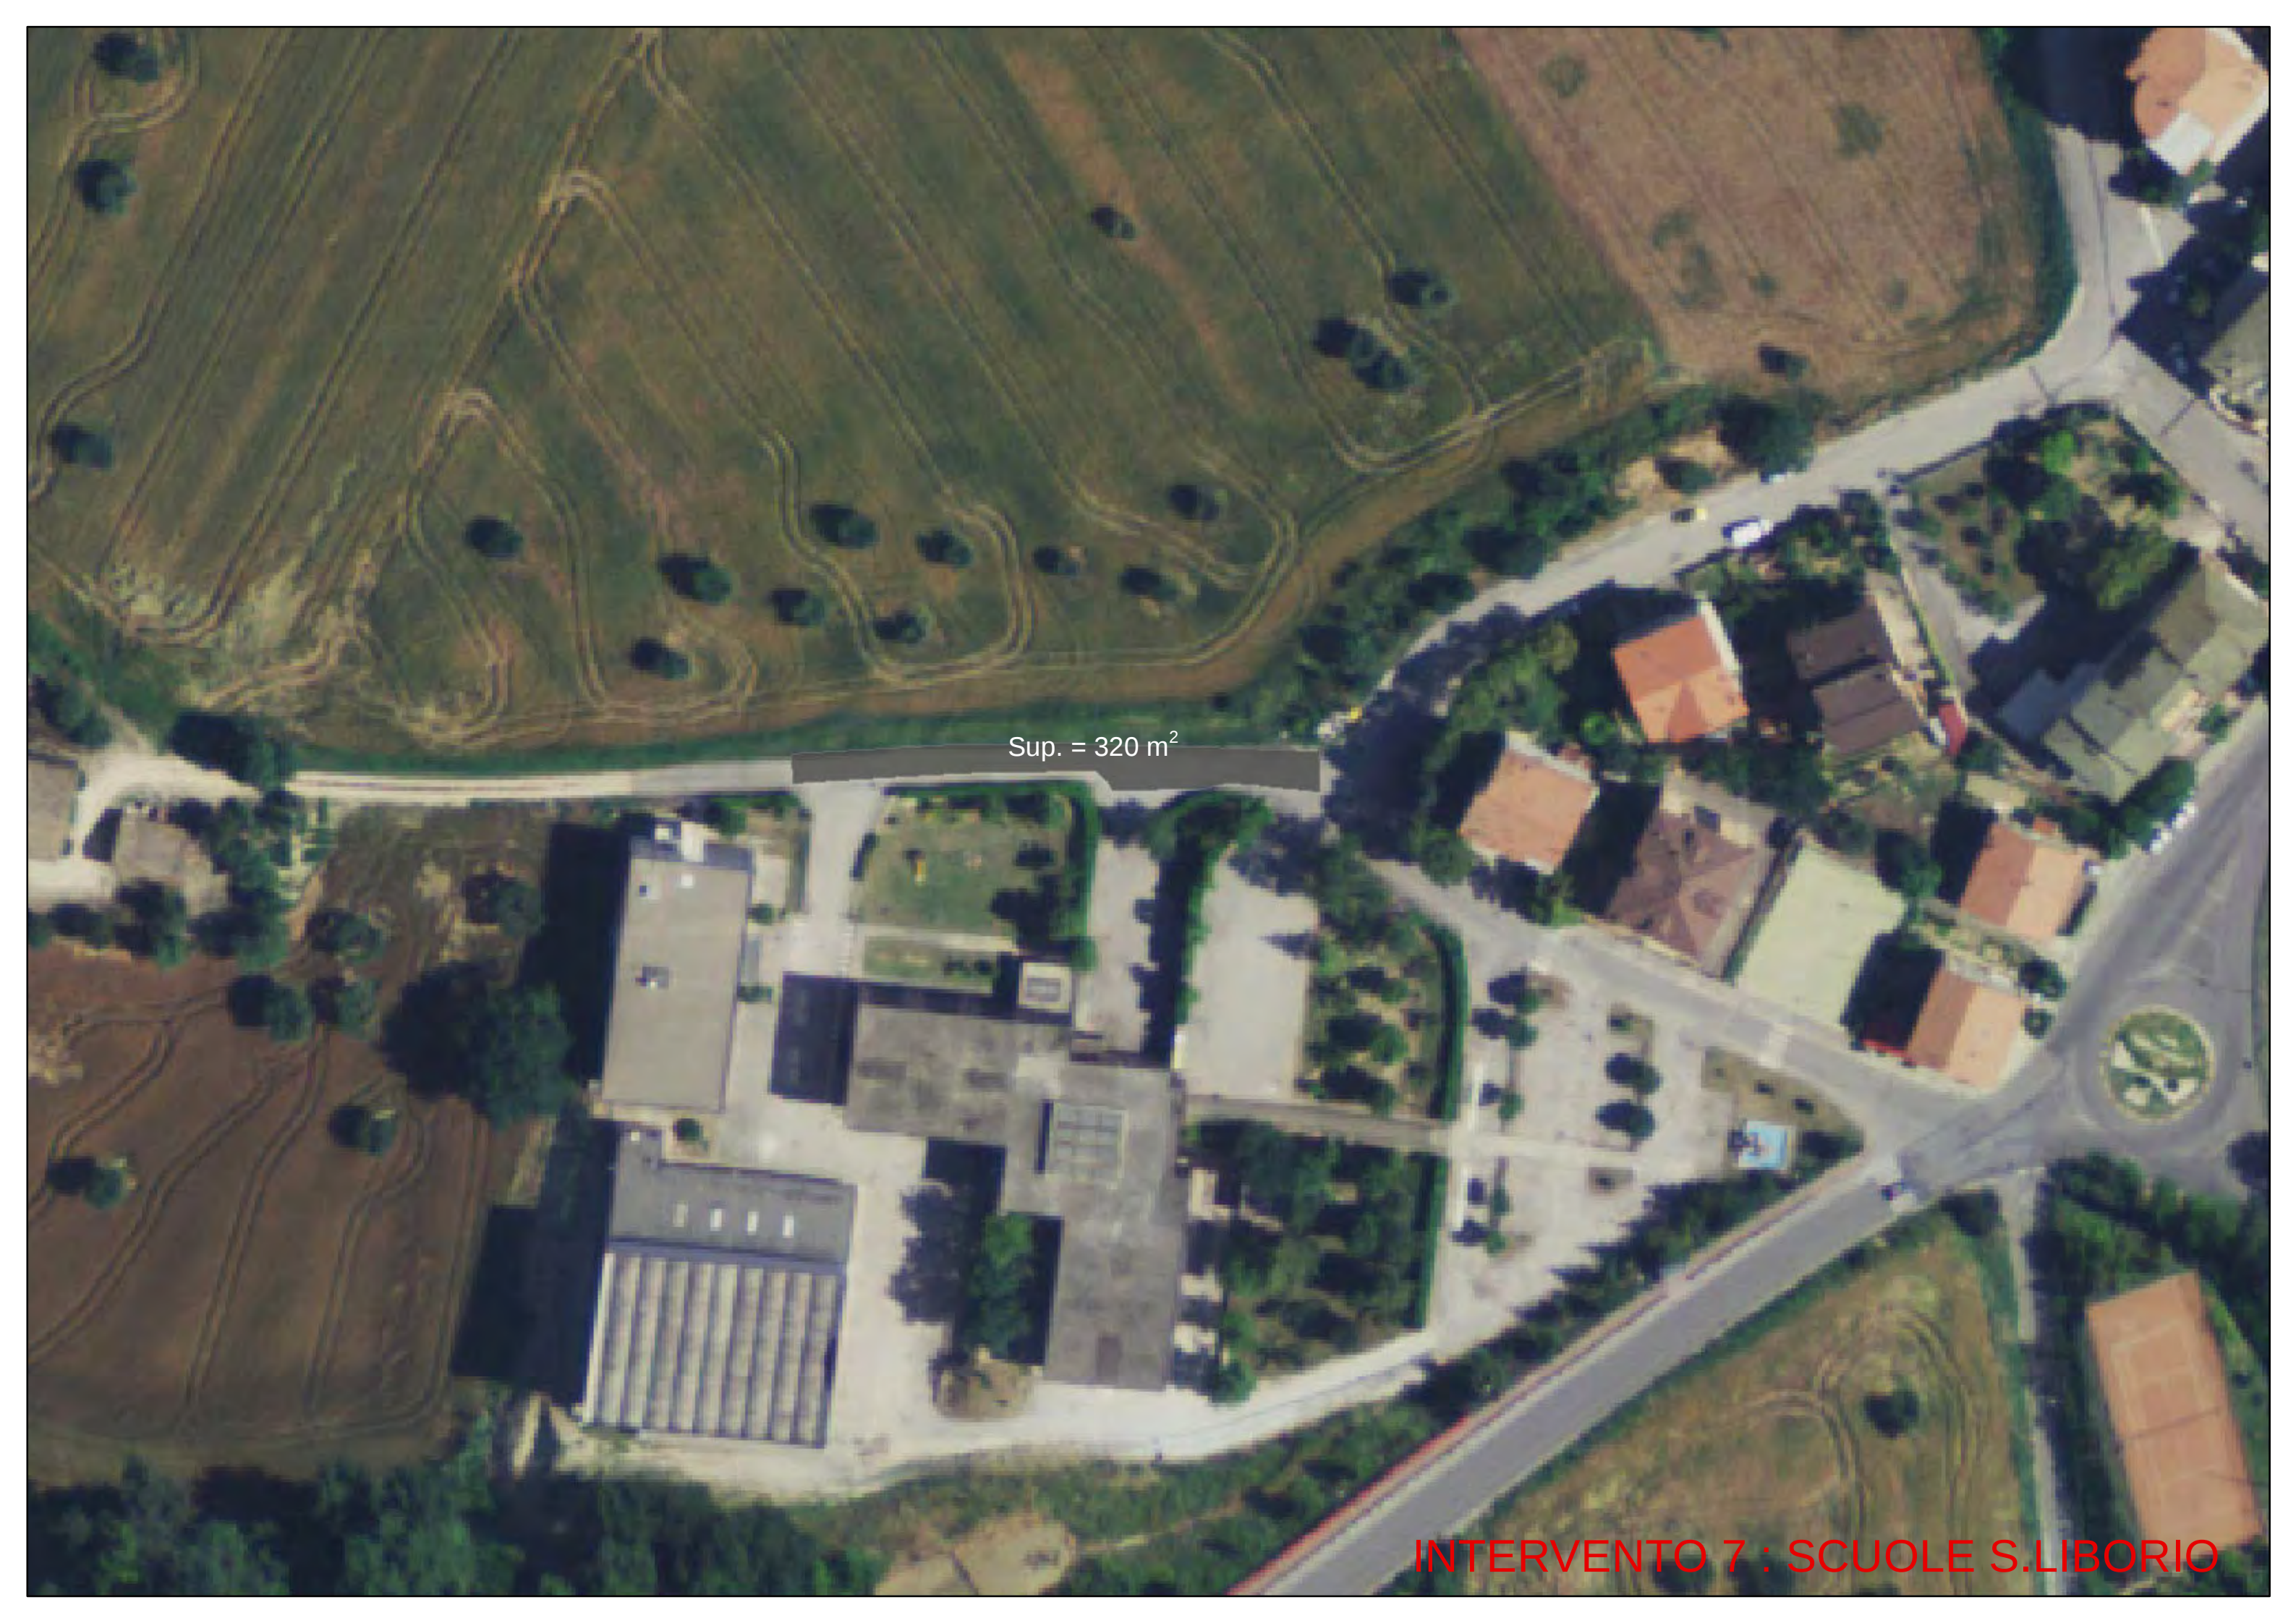
INTERVENTO 7 : SCUOLE S.LIBORIO

Sup. = 320 m<sup>2</sup>

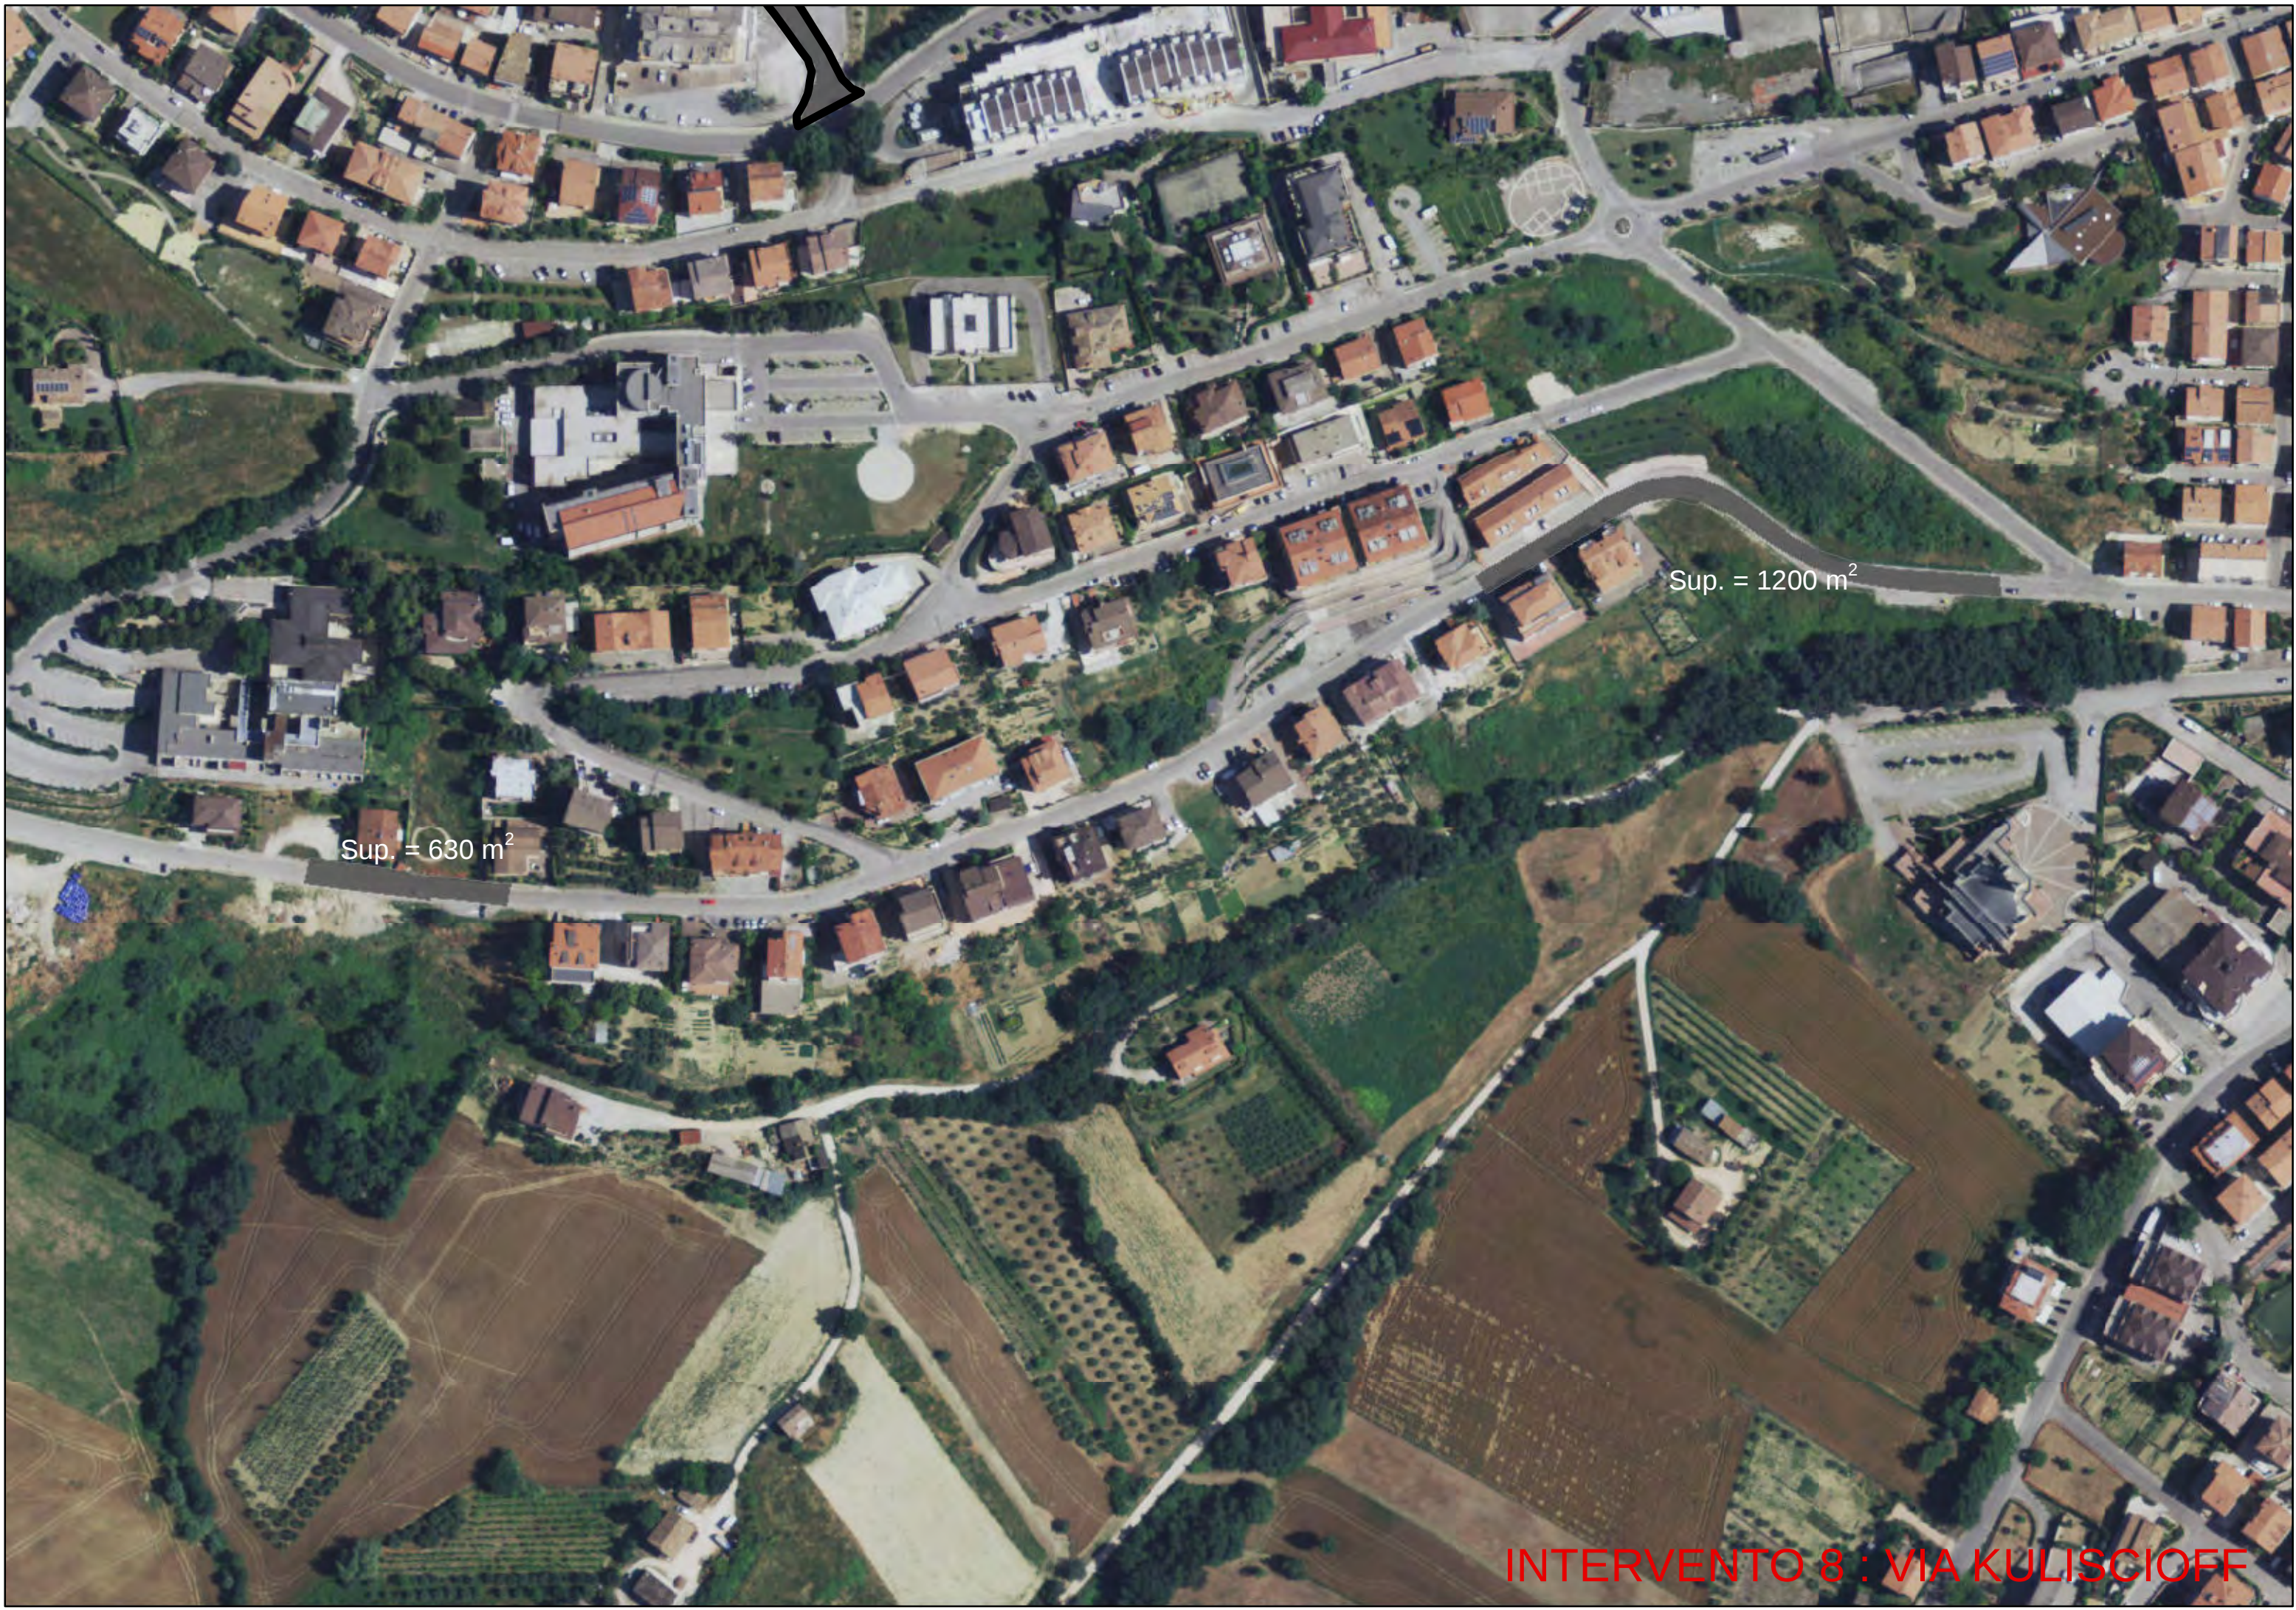
INTERVENTO 8 : VIA KULISCIOFF

Sup. = 630 m<sup>2</sup>

Sup. = 1200 m<sup>2</sup>

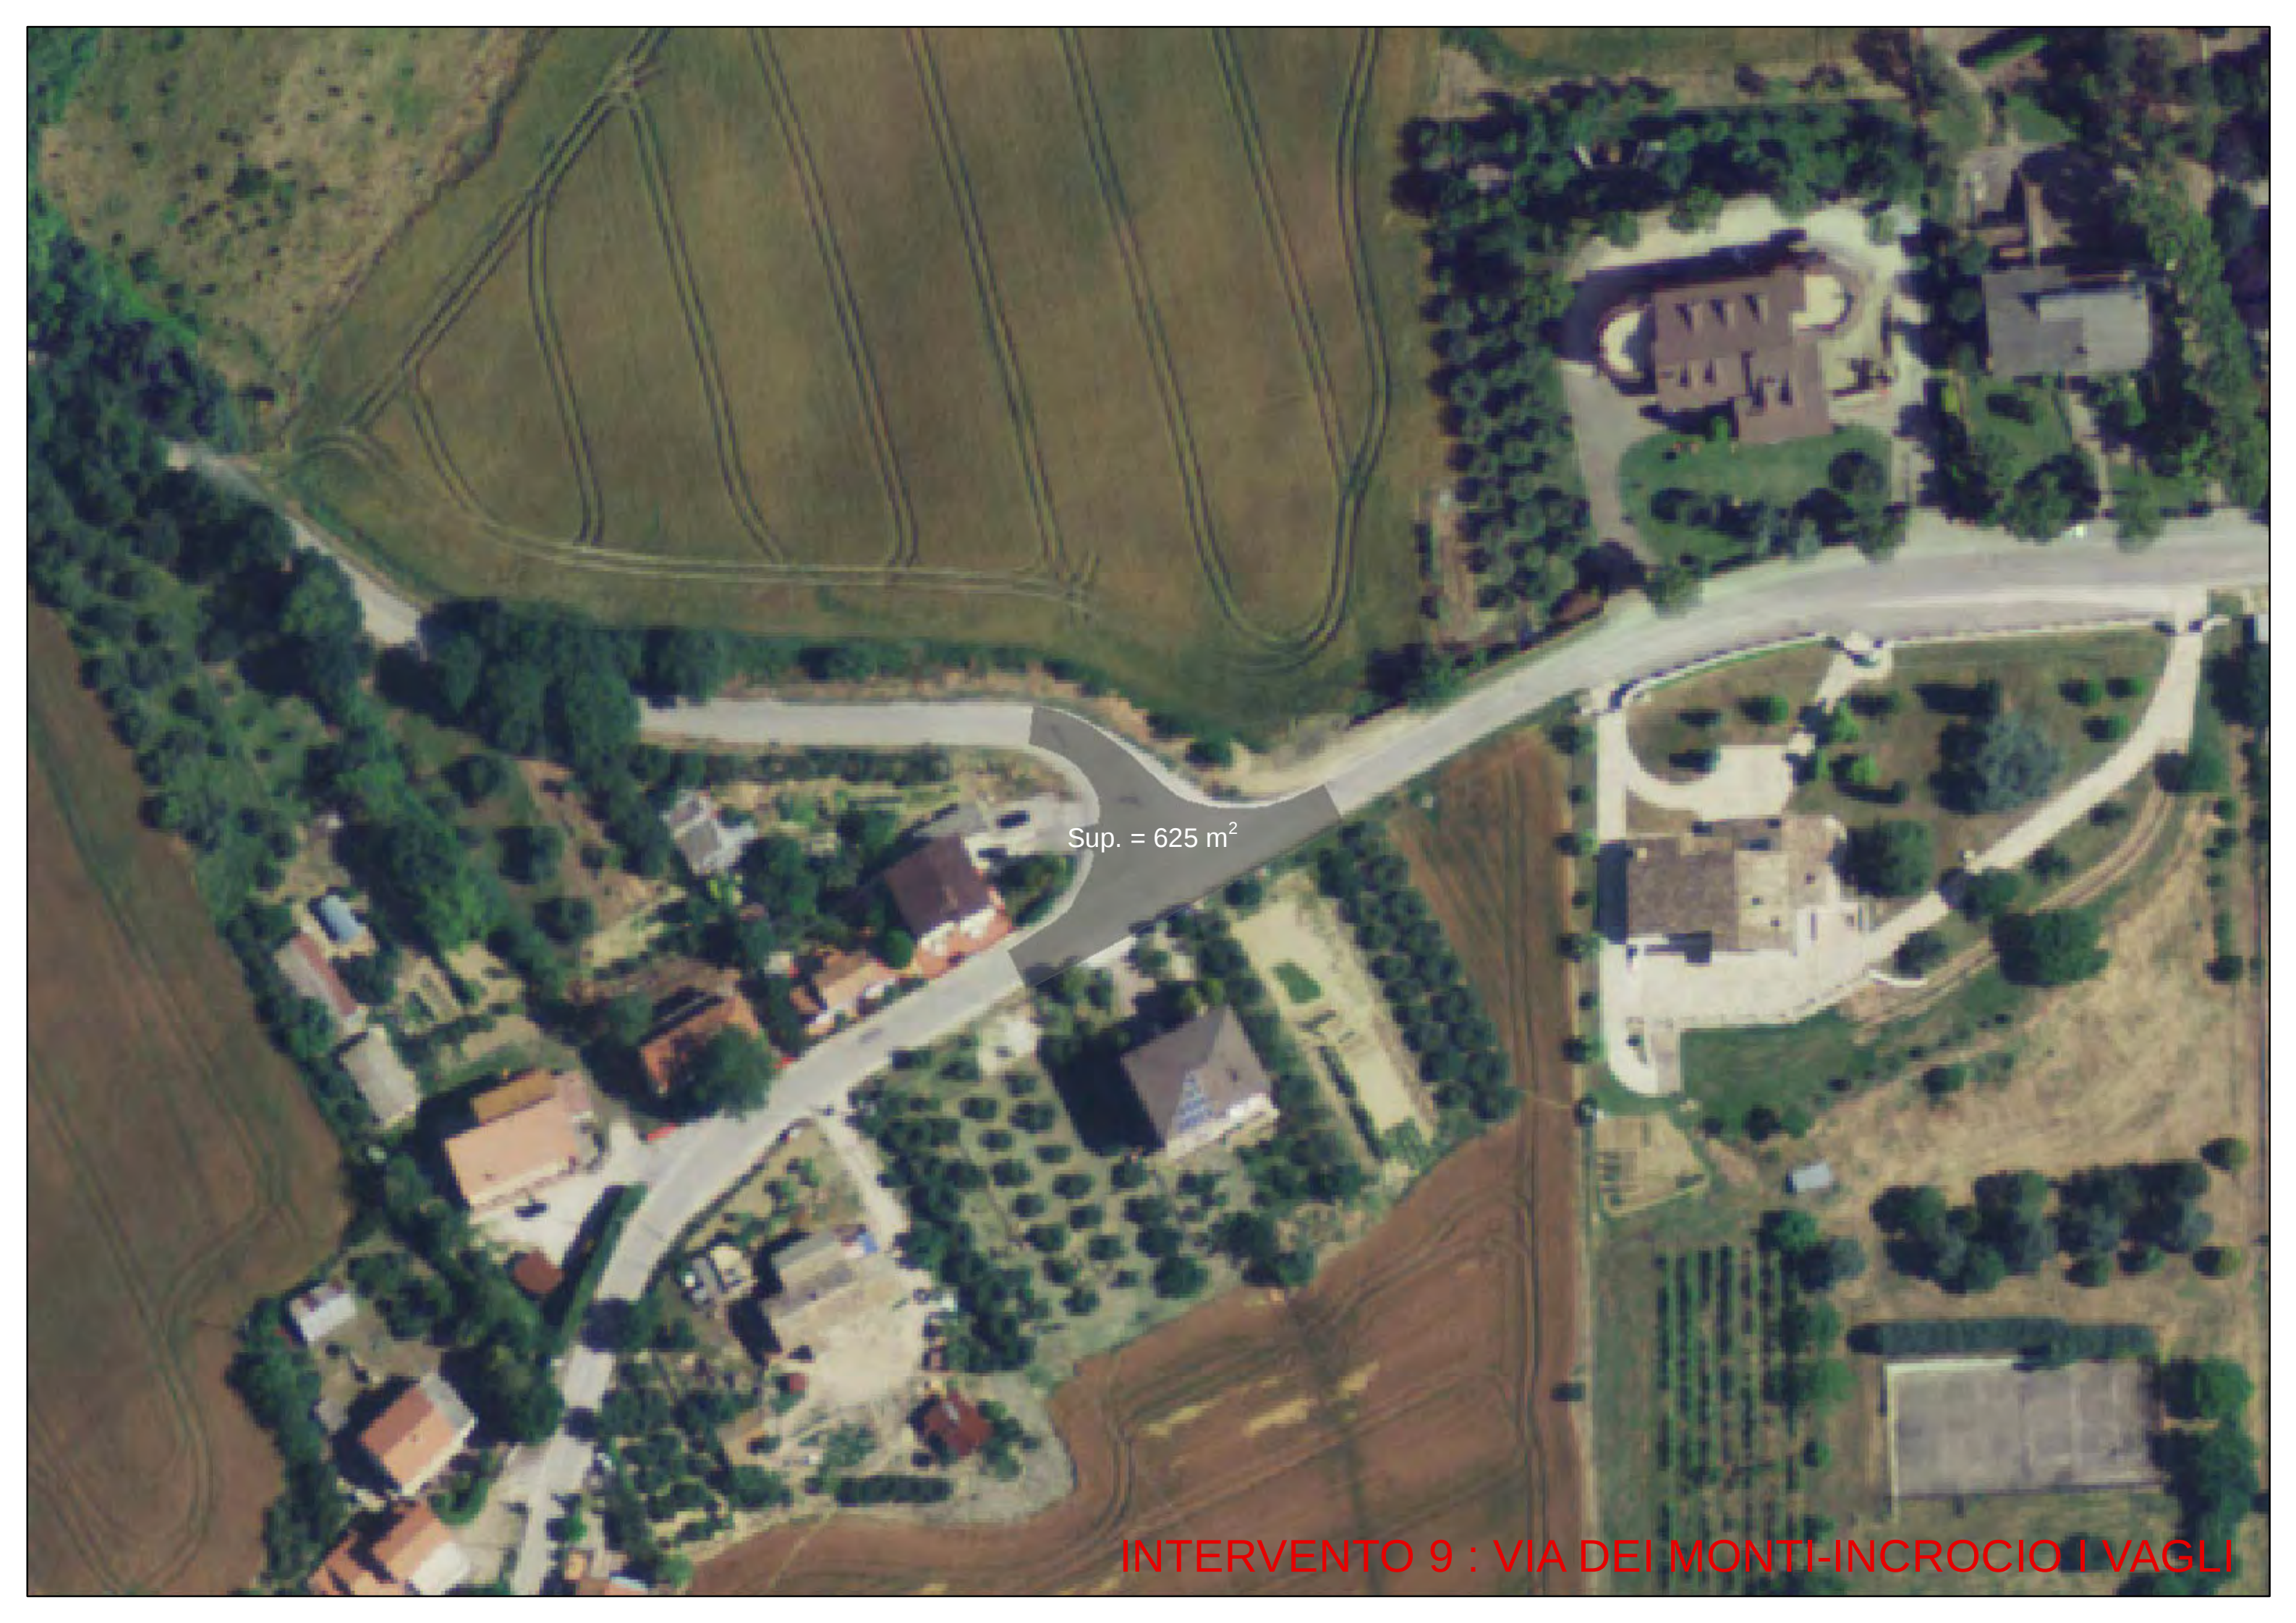
INTERVENTO 9 : VIA DEI MONTI-INCROCIO I VAGLI

Sup. = 625 m<sup>2</sup>

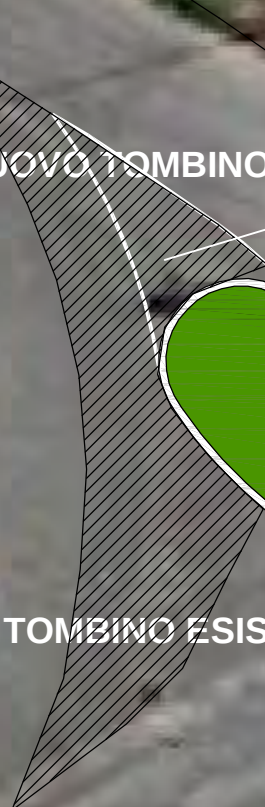
TOMBINO ESISTENTE

NUOVO TOMBINO

SUPERFICIE DI RIPROFILATURA DELLA  
CORSIA CON RICARICA DI BINDER 60 mq

NUOVA AIUOLA  
SPARTITRAFFICO

CORDOLO E ZANELLA ESISTENTE

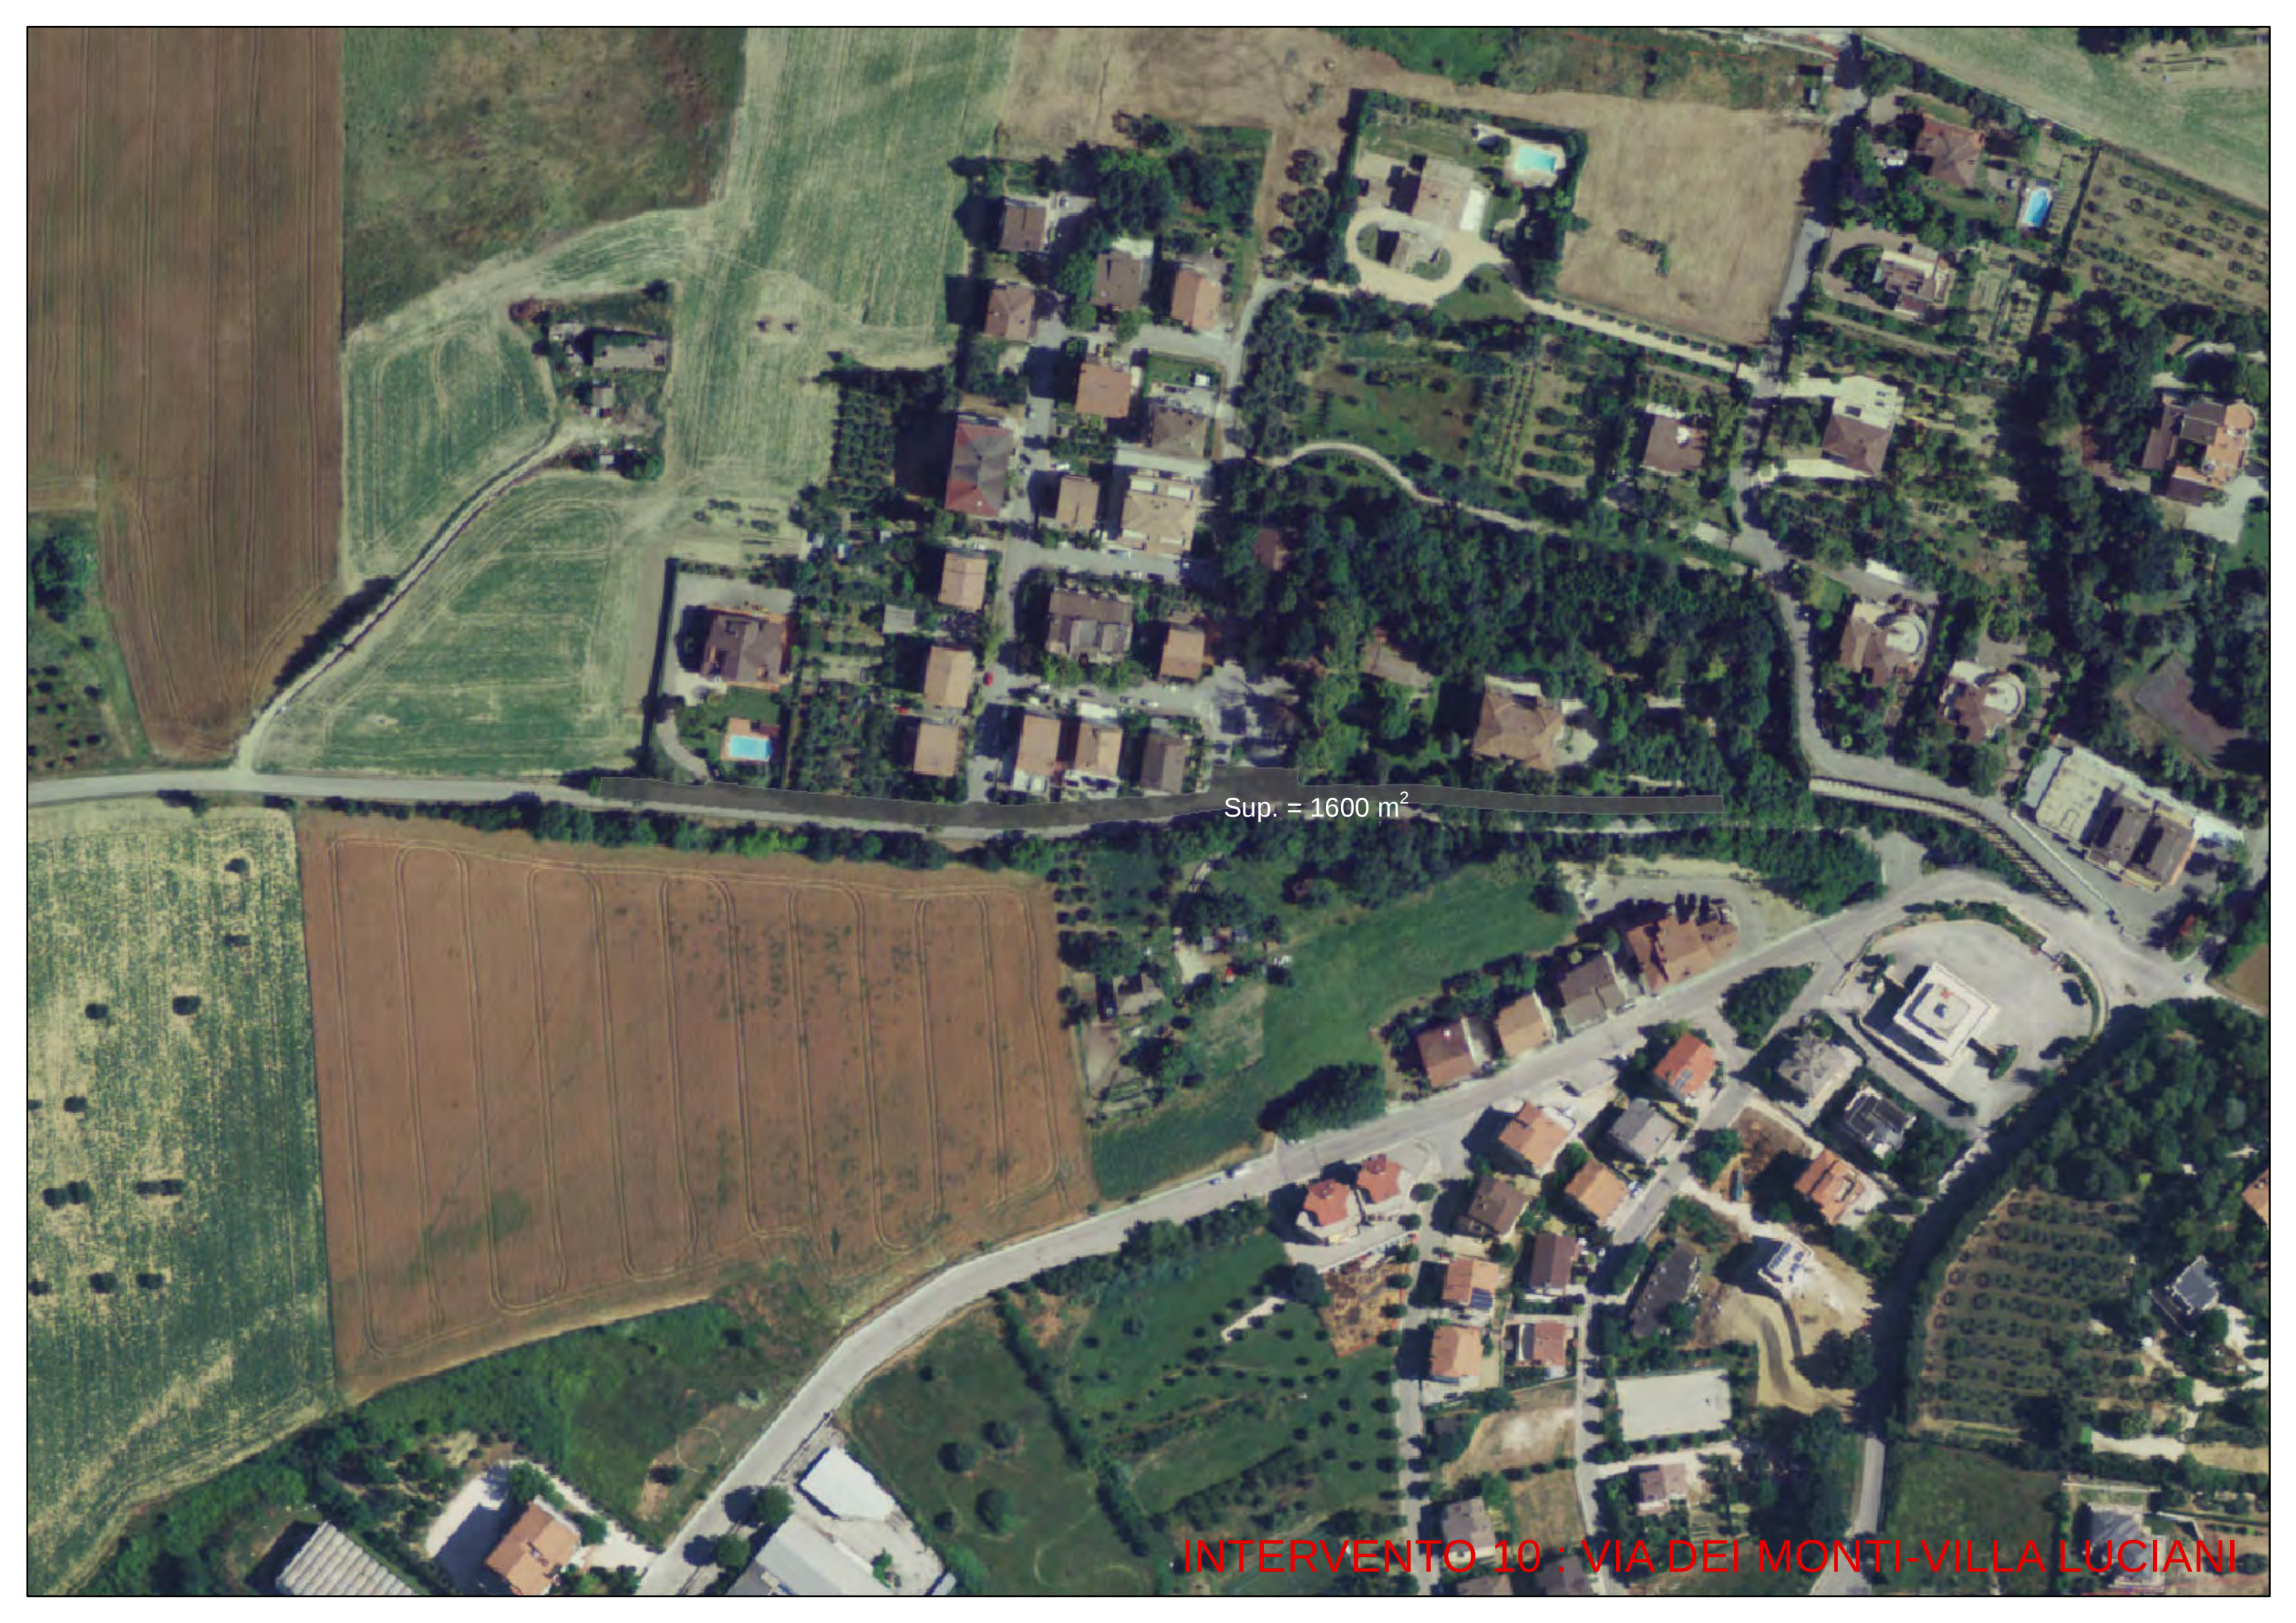
INTERVENTO 10 : VIA DEI MONTI-VILLA LUCIANI

Sup. = 1600 m<sup>2</sup>

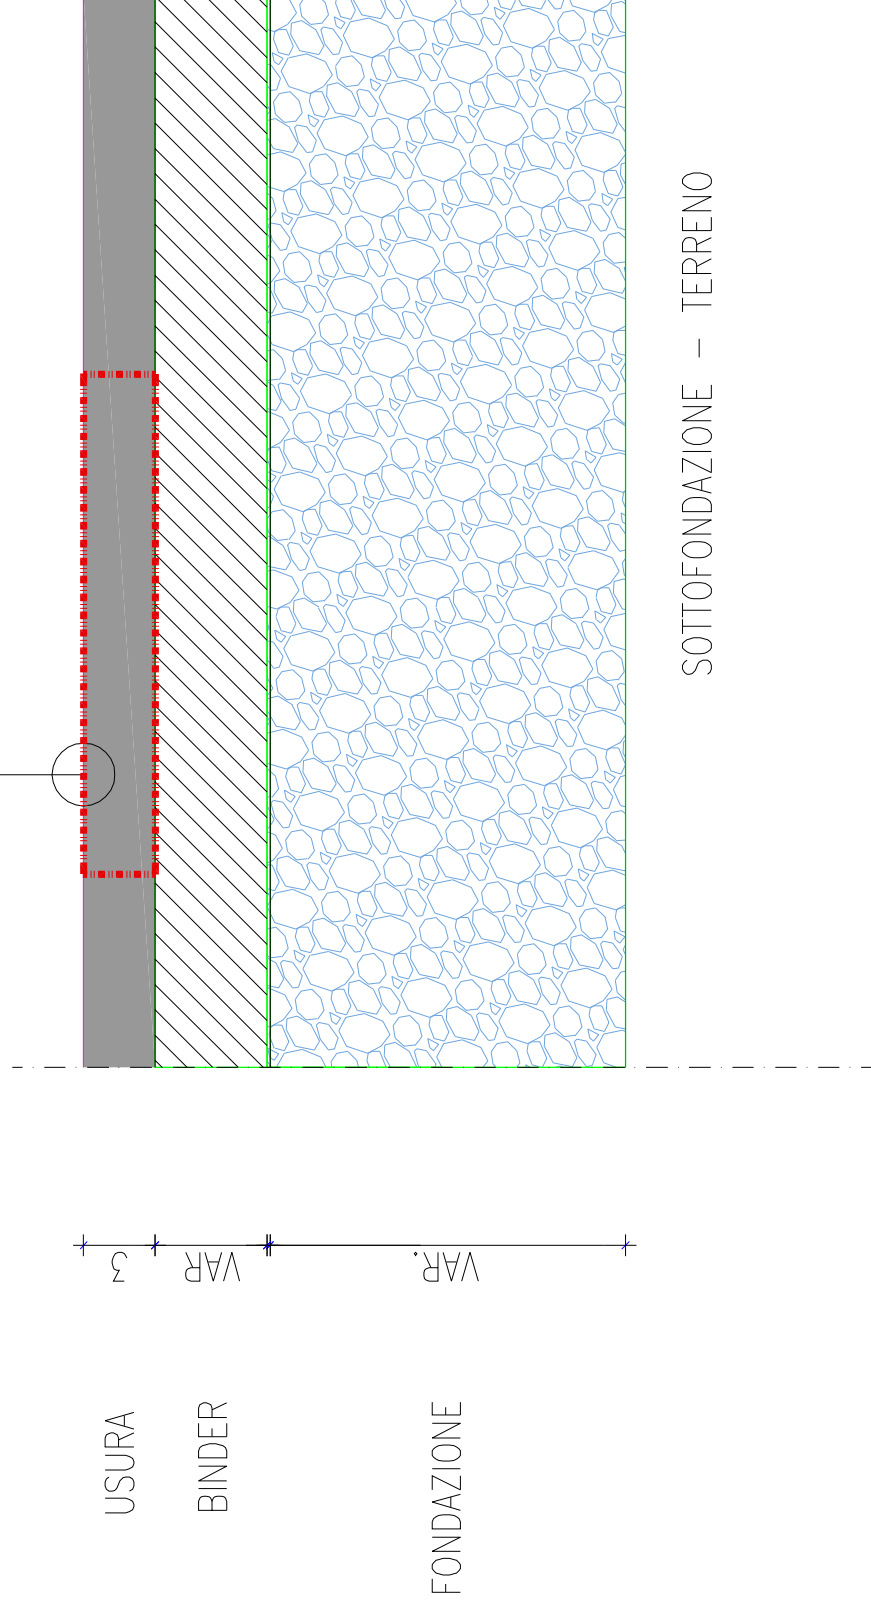
# RIFACIMENTO TAPPETINO DI USURA

## SEZIONE TIPO

L'INTERVENTO PREVEDE IL RIFACIMENTO DELLO STRATO DI USURA  
PREVIA EVENTUALE FRESATURA DELLE PARTI AMMALORATE

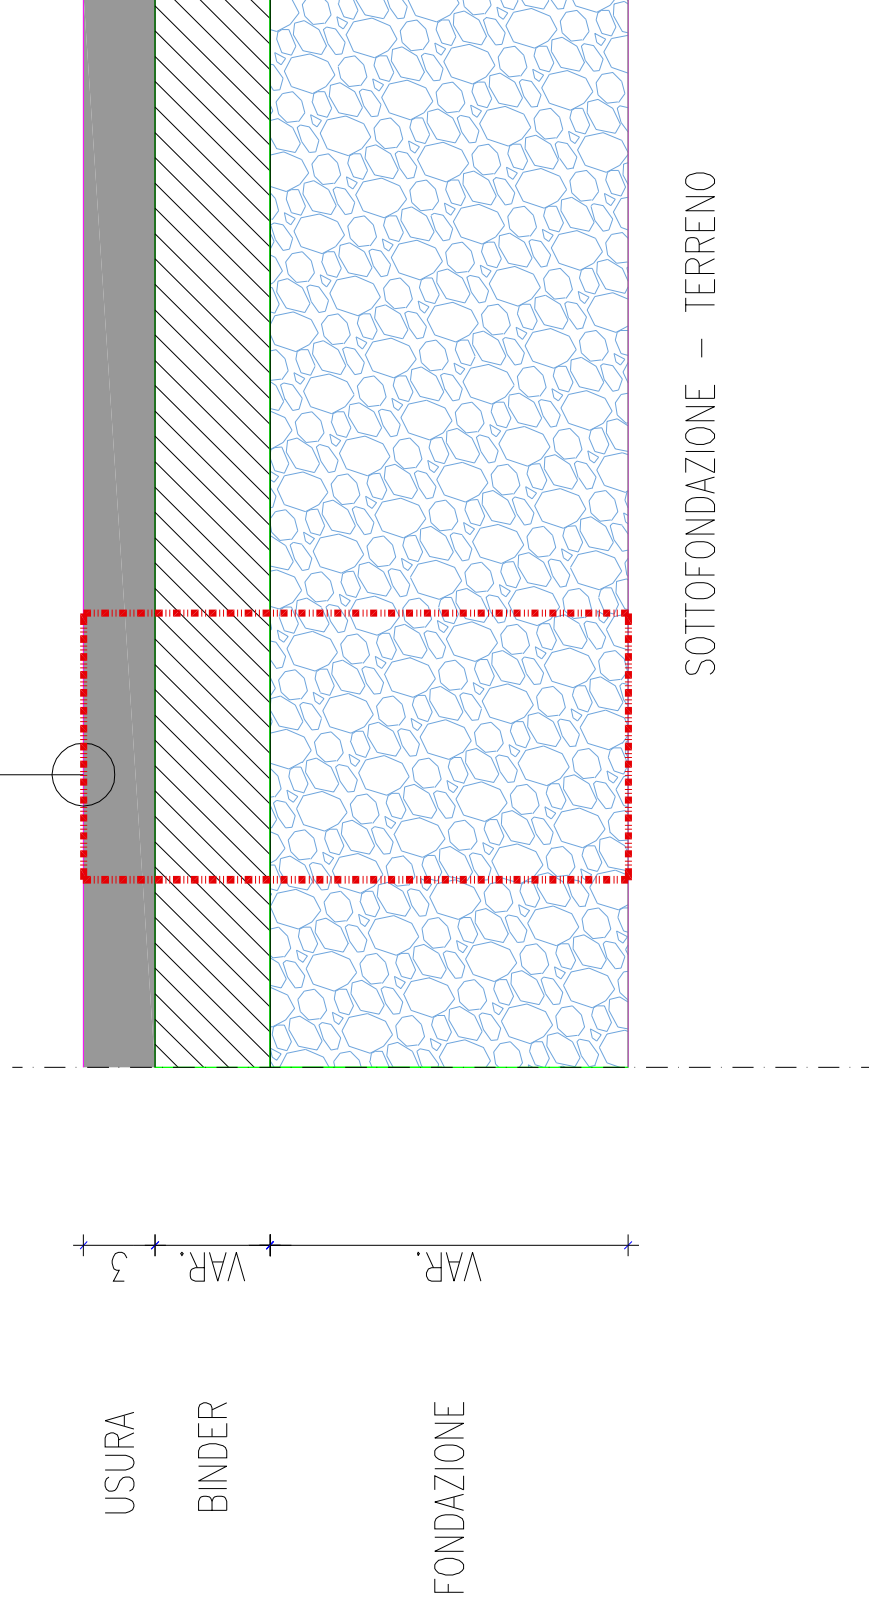
# RIFACIMENTO CORPO STRADALE

## SEZIONE TIPO

L'INTERVENTO PREVEDE IL RIFACIMENTO DELLO STRATO DI FONDAZIONE, BINDER E DEL TAPPETINO DI USURA, PREVIO TAGLIO, SCAVO E ASPORTAZIONE DELLE PARTI AMMALORATE
