**LAVORI DI MANUTENZIONE  
STRAORDINARIA VIABILITA' E  
INFRASTRUTTURE CONNESSE (MESSE IN  
SICUREZZA VARI TRATTI DI STRADE  
COMUNALI)**

**PROGETTO ESECUTIVO**

**ELABORATI GRAFICI: PLANIMETRIE E DOCUMENTAZIONE FOTOGRAFICA DEI  
SINGOLI INTERVENTI, PARTICOLARI COSTRUTTIVI**

**D1**

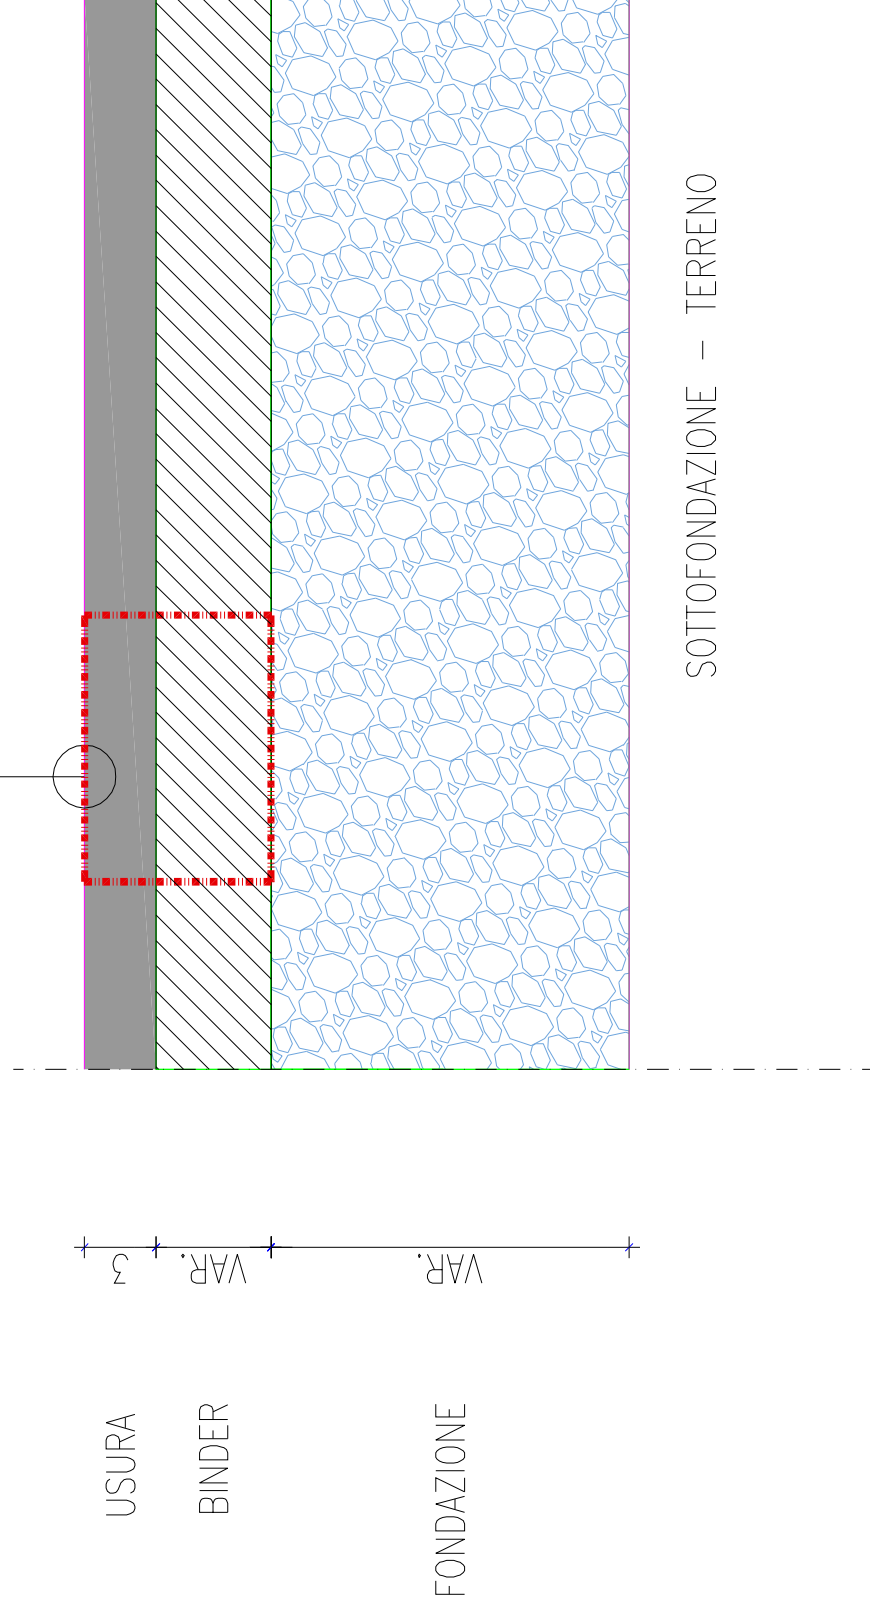
# RIFACIMENTO CASSONETTO STRADALE

## SEZIONE TIPO

L'INTERVENTO PREVEDE IL RIFACIMENTO DELLO STRATO DI BINDER E DEL TAPPETINO DI USURA, PREVIA FRESATURA DELLE PARTI AMMALORATE

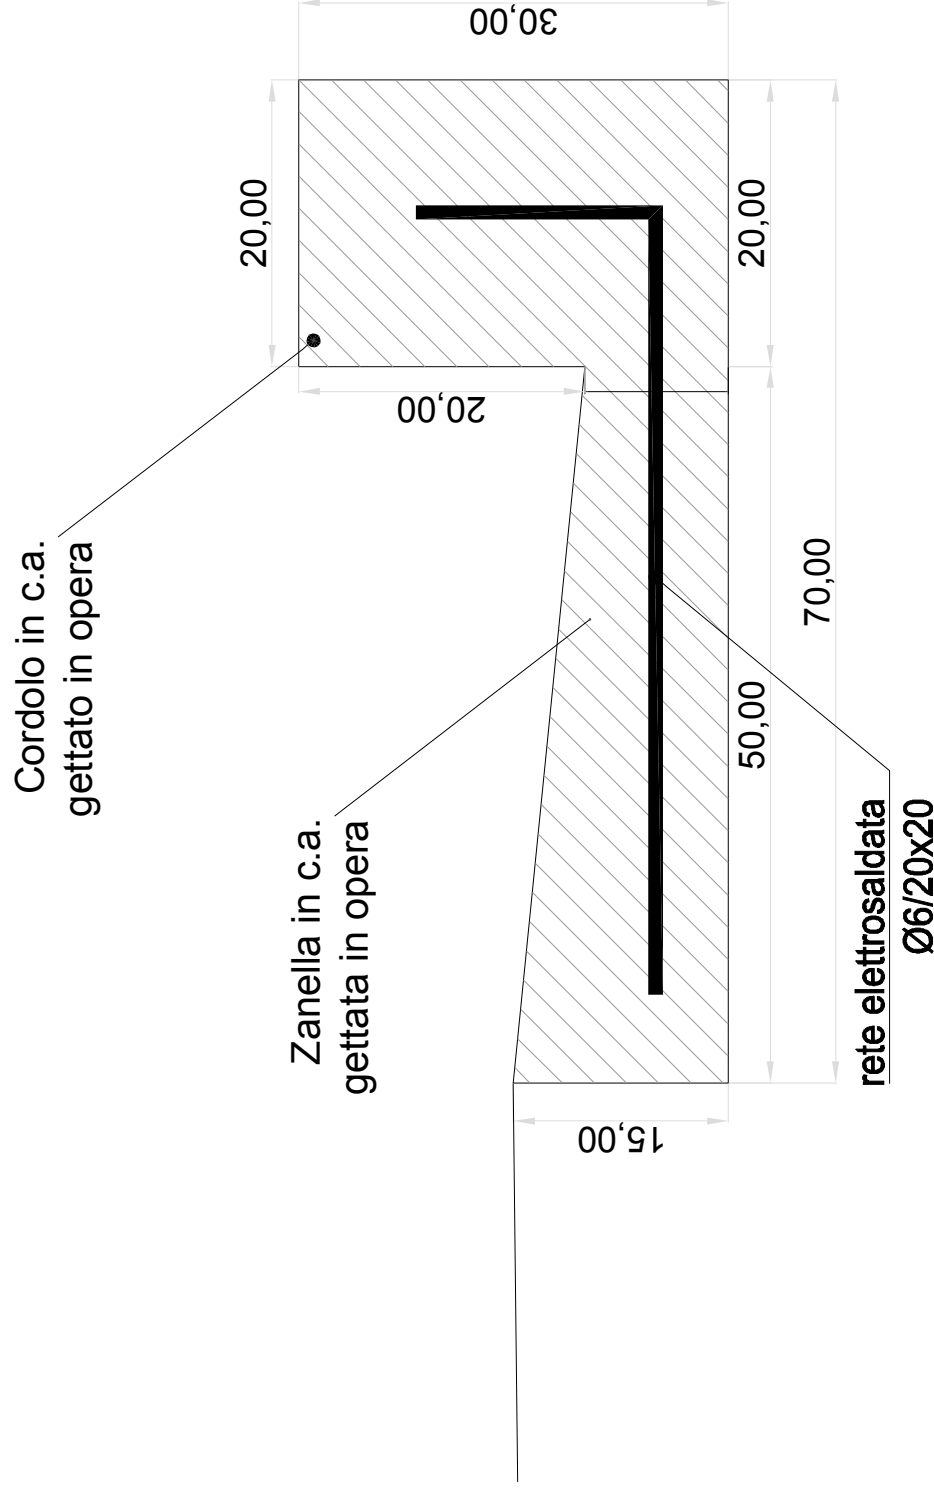
# REALIZZAZIONE DI CORDOLO E ZANELLA

## SEZIONE TIPO

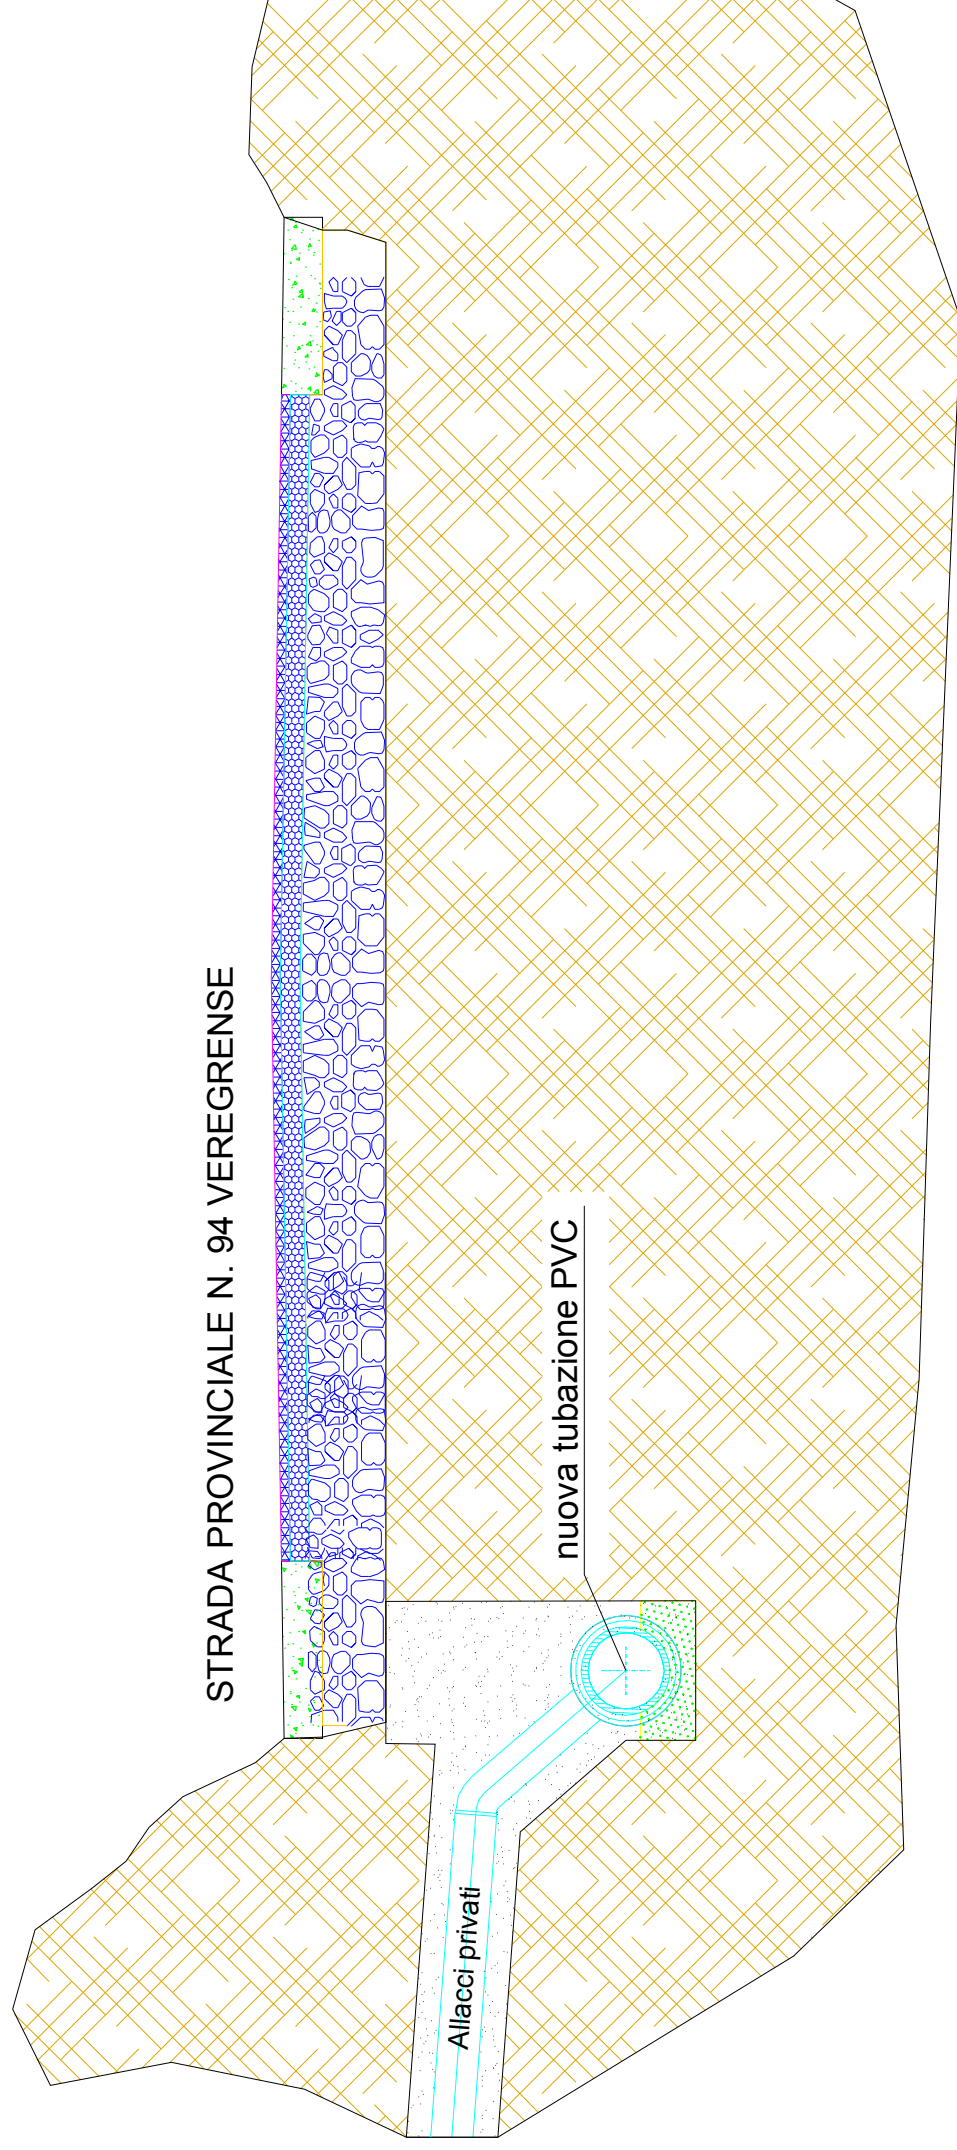
# REALIZZAZIONE NUOVA FOGNATURA

SEZIONE STRADALE TIPO
